SERVICE BULLETIN

No. 515

Piper Aircraft Corporation

Control Cable Ball Joint Retainer Installation

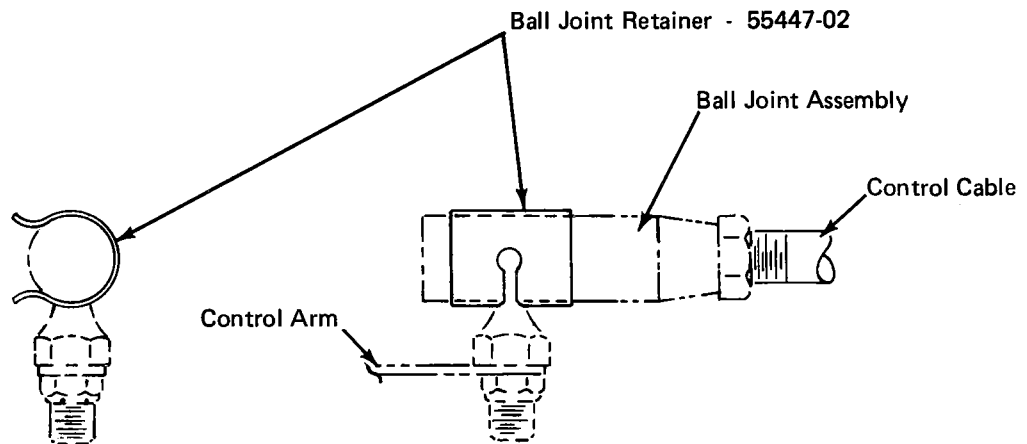
TYPICAL BALL JOINT RETAINER INSTALLATION

Purpose: There have been a few reports received from the field describing inadvertent detachment of the engine controls (i.e., throttle, prop governor and/or mixture) at the control cable ball joint attachment assembly. Failure of this ball joint assembly renders the particular control system inoperative. Although these ball joint attachment assemblies are subject to routine inspection, per published Piper inspection data, excessive wear - over a prolonged period of operation - in conjunction with inadequate inspection of this area - can permit detachment of the ball joint "ball" from its mating socket.

This service release announces availability of a safety device (retainer) that, when installed on the ball joint assembly, prevents disengagement of the ball from the socket (attached sketch/instruction sheet illustrates a typical ball joint assembly retainer installation).

1. Install ball joint retainer 55447-02, as shown above, to the control cable ball joint assemblies located in the engine compartment. See list below for appropriate model, control cable and quantity per airplane.

2. Install ball joint retainer 55447-02, as shown above, to the control cable ball joint assemblies located in the engine compartment and cockpit fuel control panel for the PA-31T. See list below for control cable and quantity.
