SERVICE BULLETIN

No. 585

Piper Aircraft Corporation

Subject: Air Control Cable Stand-off Installation

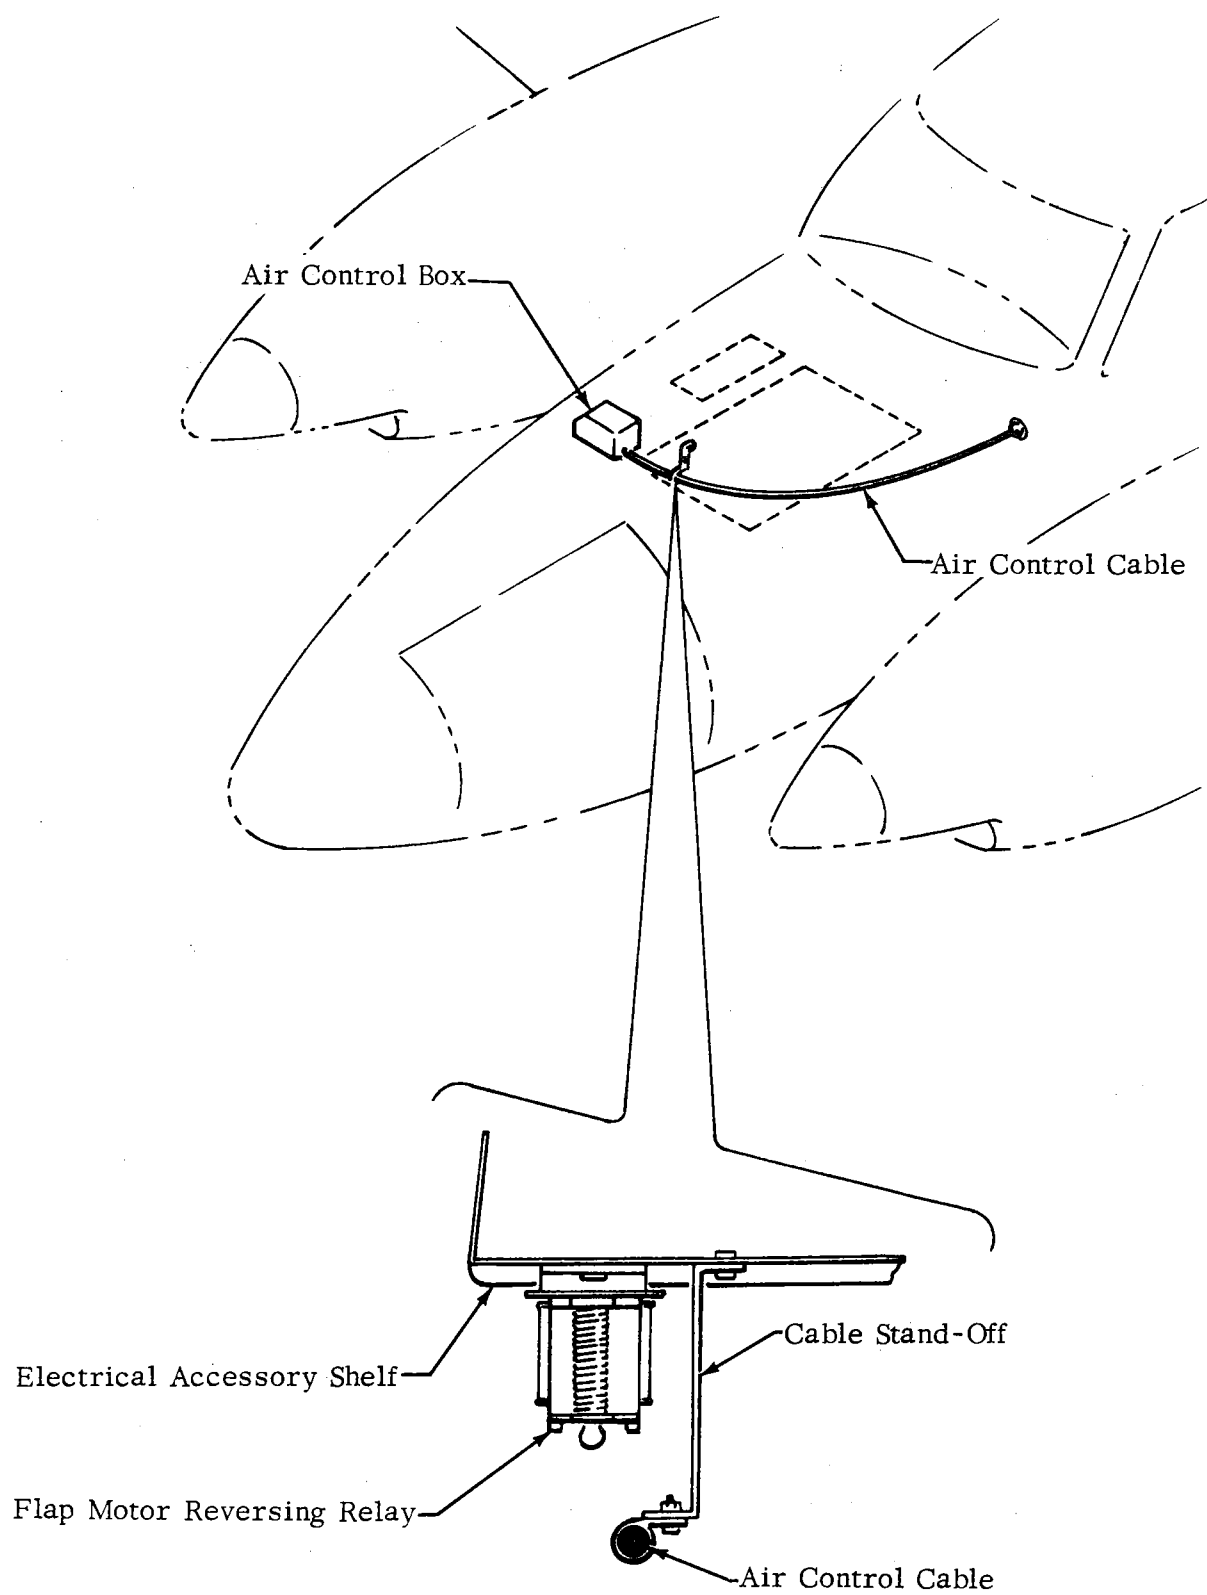
Purpose: In the above referenced aircraft, the pressurization air box control cable is routed close to the flap motor reversing relay (installed beneath the forward electrical accessory shelf). It is possible for the air control cable to contact - and interfere with the operation of the flap motor reversing relay, with resulting inoperative flaps a possibility.

This service release announces availability of a field modification kit containing material and instructions to install a "stand-off" bracket on the electrical accessory shelf to support the air control cable and prevent cable/flap motor reversing relay contact. The sketch portion of this service release visually depicts the subject area.

Instructions: Contained in Piper Kit No. 763 821, Air Control Cable Stand-off Installation.
