SERVICE BULLETIN

No. 715A

Piper Aircraft Corporation

<u>Subject:</u>	Elevator Control Tube Inspection
<u>Reason for Revision:</u>	Add Affected Aircraft; revise Purpose; revise Instructions; add PART II; add Sketch.
<u>Models Affected:</u>	<u>Serial Numbers Affected:</u>
PA-31T Cheyenne/Cheyenne II	31T-7400002 through 31T-8120070
PA-31T 1 Cheyenne I	31T-7804001 through 31T-8104073
PA-31T 2 Cheyenne II XL	31T-8166001 through 31T-8166059, 31T-8166061 and 31T-8166062

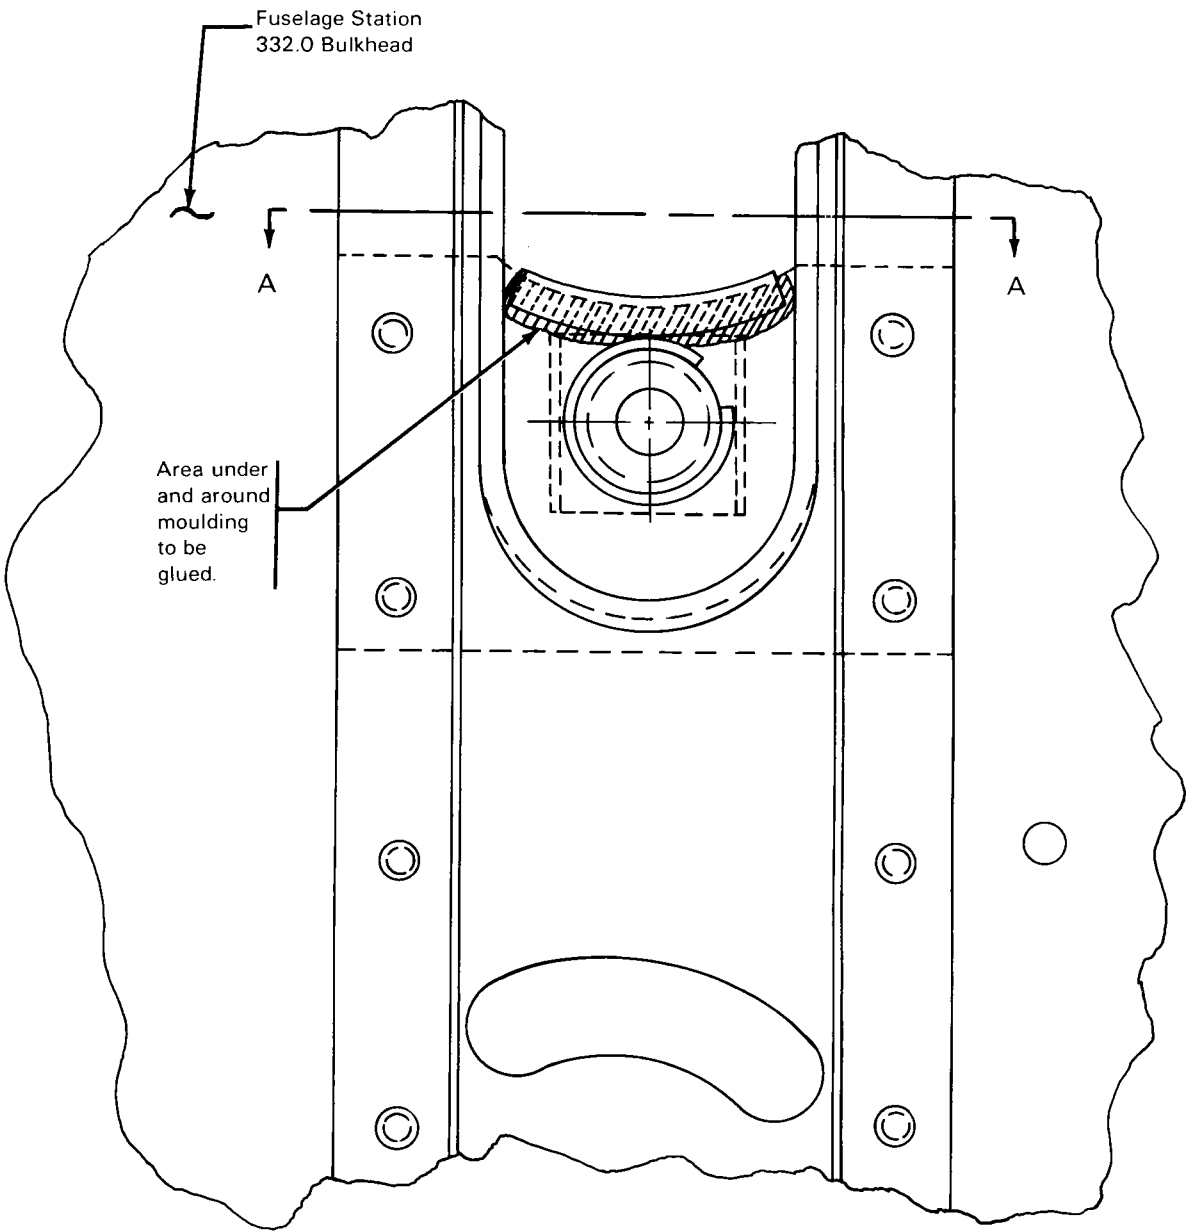
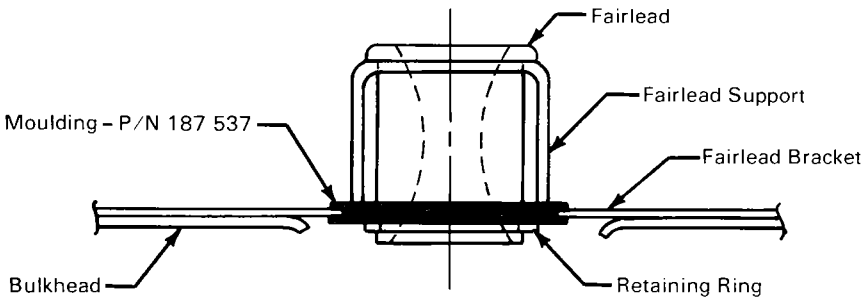
SECTION A-A
SKETCH: BRACKET INSTALLATION

Following compliance with Service Bulletin No. 715, dated July 15, 1981, several reports were received indicating that when the aircraft were in cruise configuration, there could be a slight rubbing of the elevator control tube against the trim strip installed at Fuselage Station 332.0 bulkhead.

8. Reprime the elevator control tube.
9. At the bottom of the throughway in the Station 332.0 bulkhead, position the fairlead support, and file the fairlead bracket as shown in attached Sketch, Section A-A, to assure at least .125 inch clearance from the elevator control tube to the fairlead bracket after the protective moulding is installed.

10. With fairlead support as shown in Sketch, place a piece of rubber moulding, Piper Part No. 187 537, across the bracket.
11. Using existing hardware and bolt stops, reinstall the elevator control tube. While moving the elevator through its full travel, determine that the clearance between the control tube and the protective moulding does not decrease to less than .125 inch.

12. Using 3M EC847 adhesive or equivalent, glue the rubber moulding in place as shown in Sketch.
13. Check elevator controls for proper system operation and rigging. (Refer to Service Manual, Section V).

5. Reprime the elevator control tube.
6. At the bottom of the throughway in the Station 332.0 bulkhead, position the fairlead support and file the fairlead bracket as shown in the attached Sketch, Section A-A, to assure at least .125 inch clearance from the elevator control tube to the fairlead support bracket after the protective moulding is installed.

7. With fairlead support as shown in Sketch, place a piece of rubber moulding, Piper Part No. 187 537, across the bracket. Reinstall the control tube and insure that the clearance between the tube and the protective moulding does not decrease to less than .125 inch at any point in elevator travel.

8. Using 3M EC 847 adhesive or equivalent, glue the rubber moulding in place as shown in sketch.
9. Check elevator controls for proper system operation and rigging. (refer to Service Manual, Section V.)
