SERVICE BULLETIN

No. 733

Piper Aircraft Corporation

Emergency Exit Window Installation

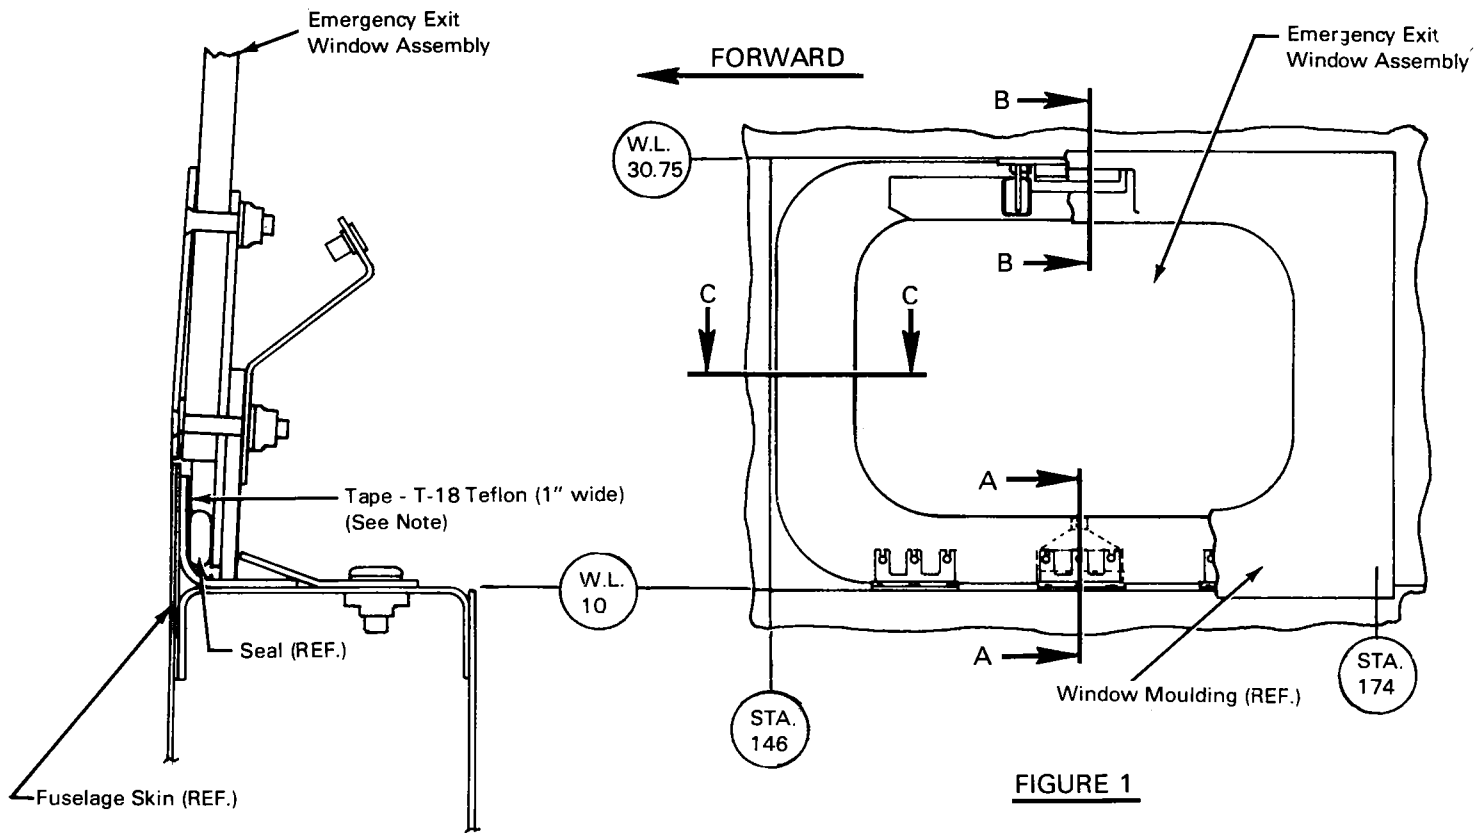
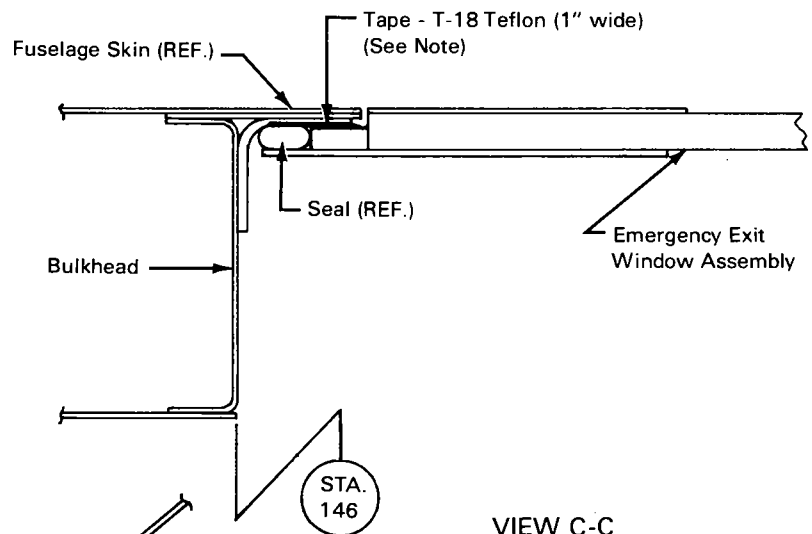
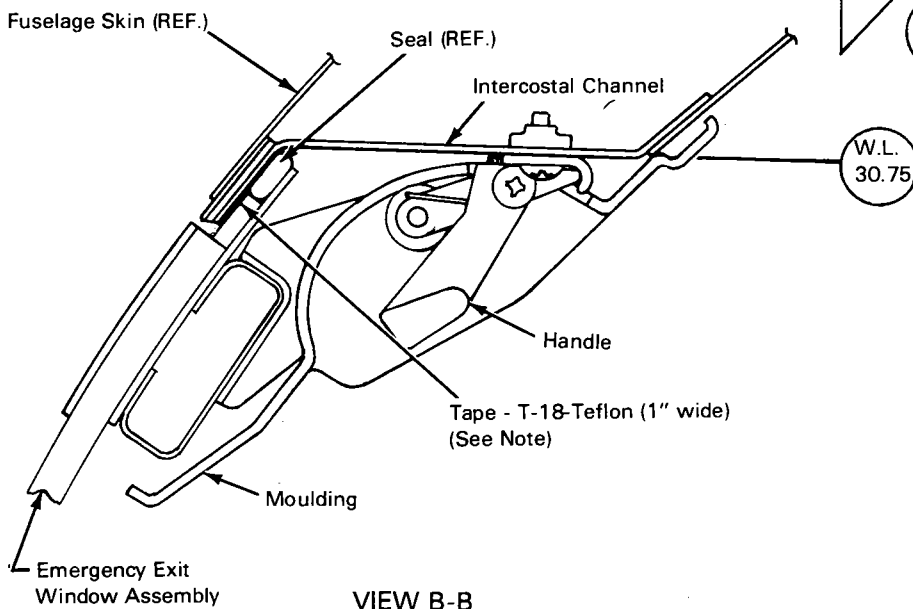
SKETCH "A"

Purpose: In the above-listed aircraft the emergency exit window could stick in the fuselage frame, requiring greater than acceptable force for removal. This could cause difficulty in an emergency situation.

1. Remove the emergency exit window.
2. With Methyl Ethyl Ketone, clean the fuselage frame in the area of the fuselage to remove excess fuselage sealant.
3. Refer to attached sketch. Install 1 inch wide Teflon Tape around the sill as shown. Make sure the surface of the tape is clean.
4. Reinstall the window assembly. Remove and reinstall to insure proper operation.
5. Make appropriate logbook entry of compliance with this Service Release.

NOTE: The T-18 Teflon Tape Must Adhere To The Fuselage Window Frame Prior To Installing The Emergency Exit Window Assembly.
