Piper Aircraft Corporation  
Vero Beach, Florida, U.S.A.

# SERVICE *No.* 841A BULLETIN

\*\*\*\*\*  
\* PIPER CONSIDERS \*  
\* COMPLIANCE MANDATORY \*  
\*\*\*\*\*  
Date October 8, 1987 M

Main Landing Gear Forward Side  
Brace Inspection/Replacement

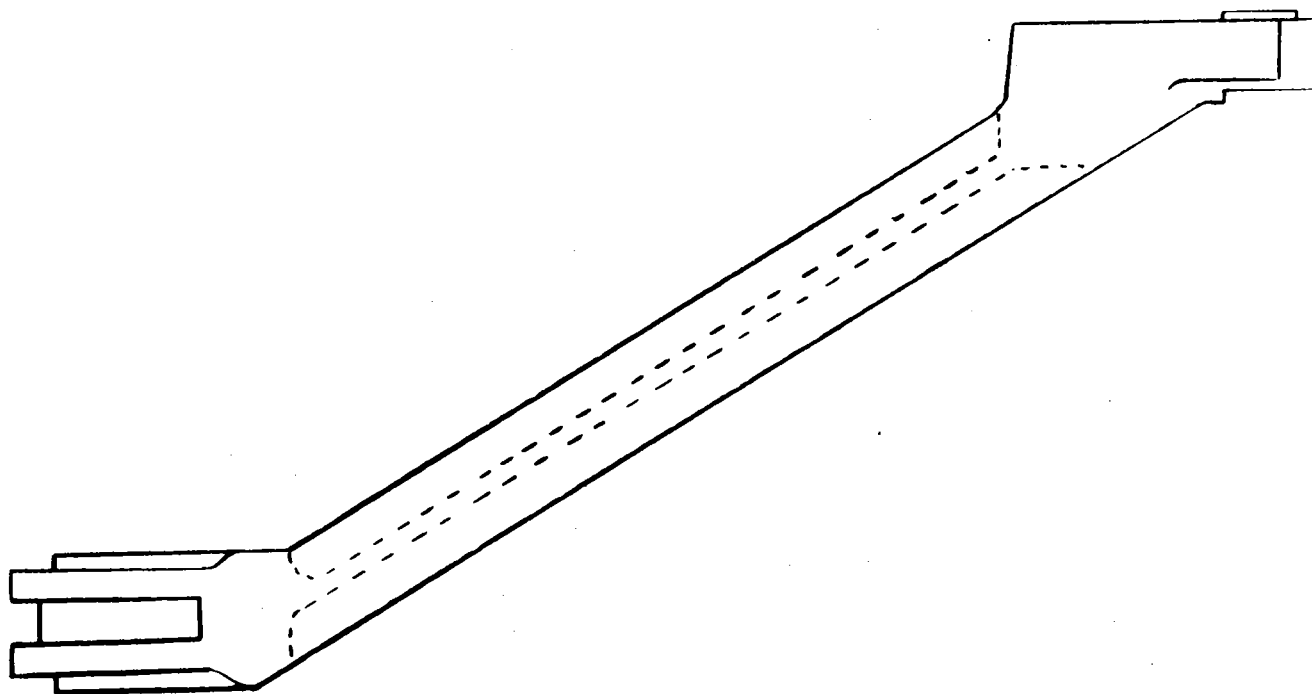
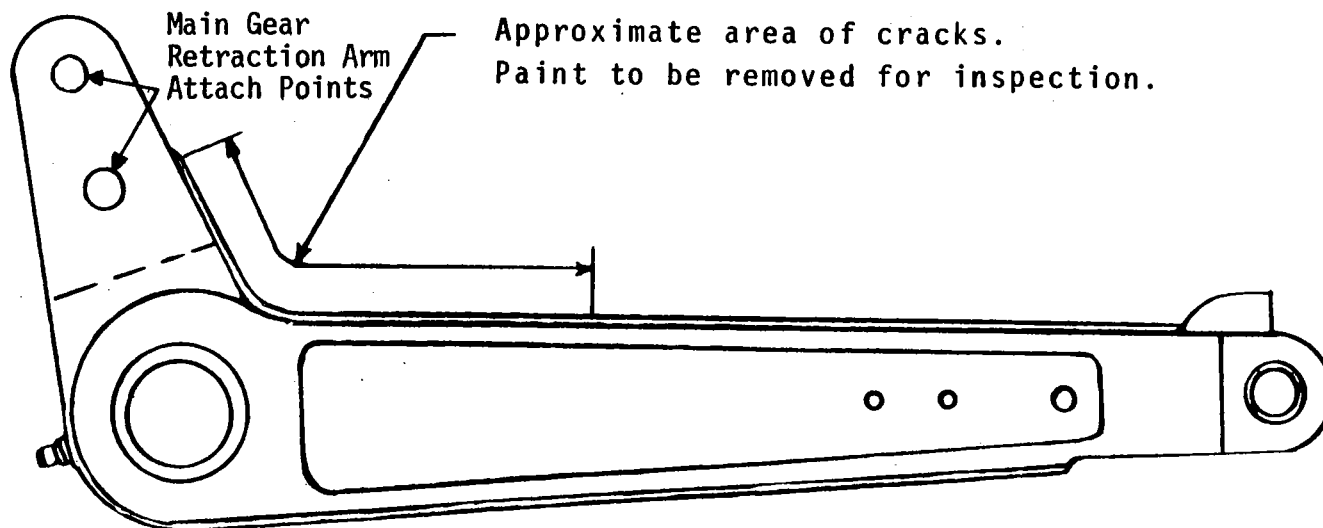
SKETCH "A"

**PURPOSE:** Field reports have been received of main landing gear forward side braces cracking during the landing gear cycle. A failed side brace link would prevent landing gear retraction and could cause landing gear collapse under high side load conditions. It has also been determined that any operation of the landing gear above maximum landing gear operating speed ( $V_{LO}$ ) greatly increases stress and could cause side brace failure.

1. Remove paint in area indicated in Sketch "A" on both Main Landing Gear Forward Side Braces, Piper Part Number 57448-02 left and 57448-03 right for PA-42, PA-42-720R and PA-42-720; Piper Part Number 40279-16 left and 40279-17 right for PA-31T3.

2. Inspect area for cracks using dye penetrant or zygo procedures, paying particular attention to the top surface of the affected parts.
3. If cracking is indicated, replace the affected part prior to further flight, per the appropriate aircraft Maintenance Manual.
4. Make the appropriate logbook entry of compliance with PART I of this Service Bulletin.

1. Refer to the appropriate Maintenance Manual for specific instructions.
2. Remove main landing gear forward side brace on left and right main landing gear.
3. Install new Main Landing Gear Forward Side Braces, Piper Part Number 85165-02 left and 85165-03 right.

NOTE: Installation of new Improved main landing gear forward sidebraces will require the use of longer bolts at the main gear retraction arm to sidebrace attach points, see Material Required. Refer to Sketch 'A'.
