Piper Aircraft Corporation  
Vero Beach, Florida, U.S.A.

# SERVICE No. 845A BULLETIN

(Service Bulletin No. 845A supersedes and voids Service Bulletin No. 845, dated August 18, 1986)

SUBJECT: Main Landing Gear, Forward Side  
Brace Inspection/Replacement

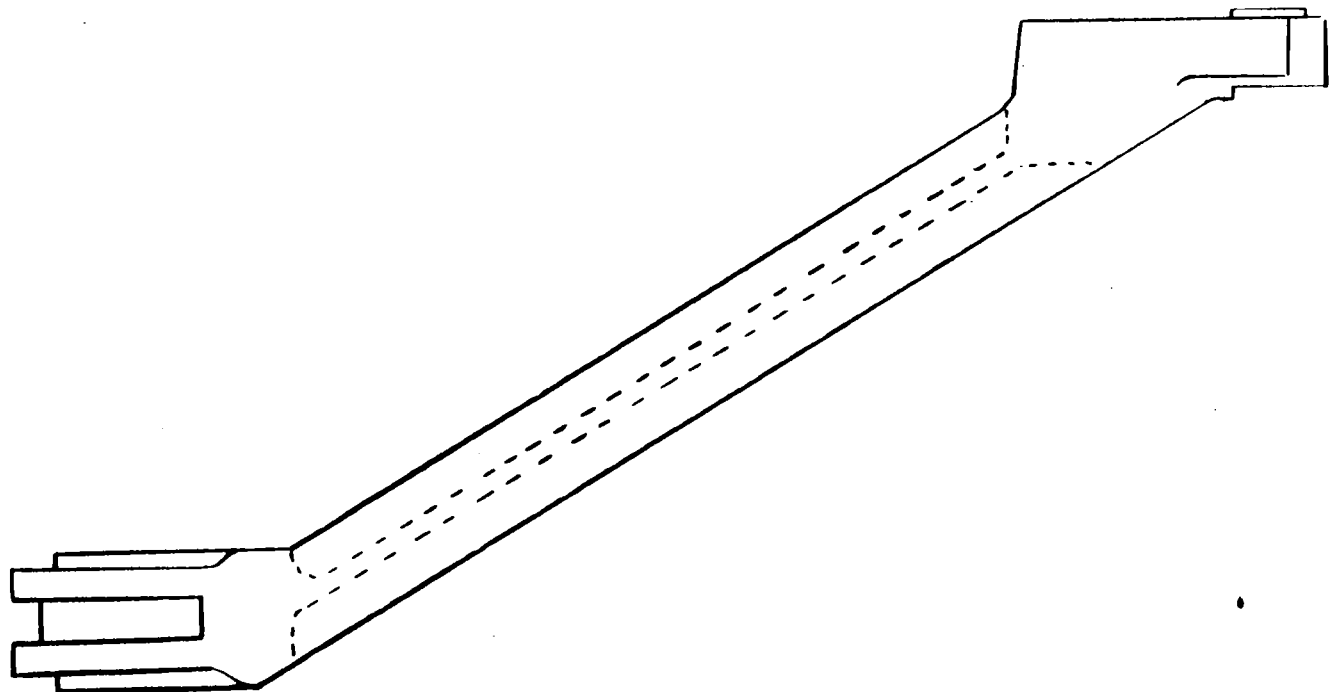
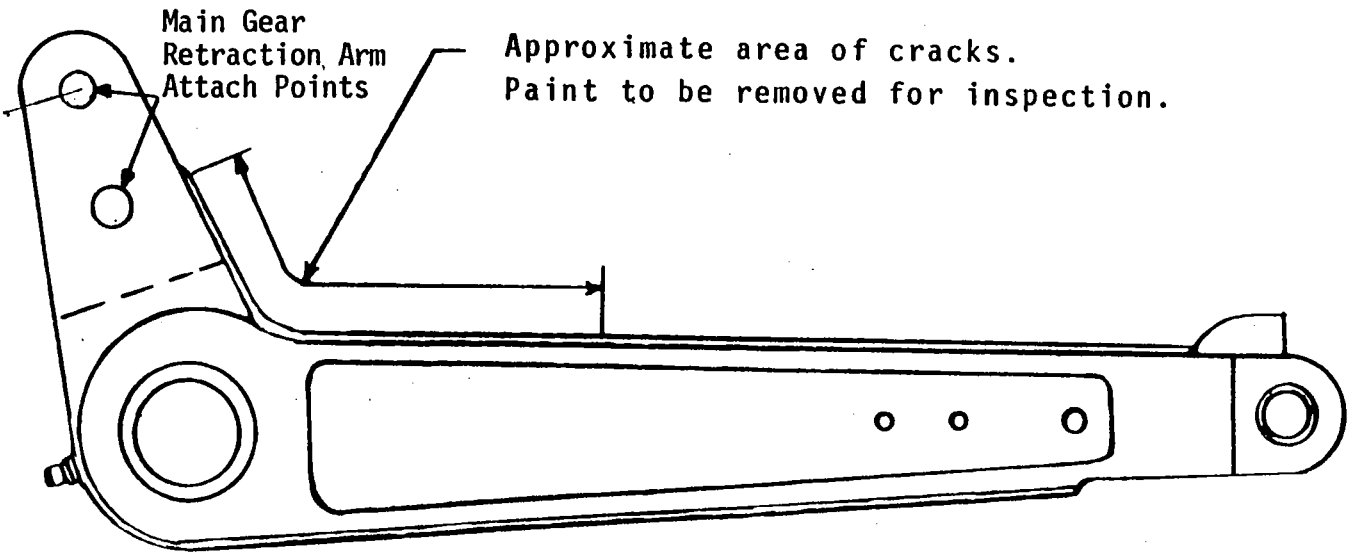
SKETCH "A"

Field reports have been received of main landing gear forward side braces cracking during the landing gear cycle. A failed side brace would prevent landing gear retraction and could cause landing gear collapse under high side load conditions. It has also been determined that any operation of the landing gear above maximum landing gear operating speed ( $V_{LO}$ ) greatly increases stress and could cause side brace failure.

1. Remove paint in area indicated on Sketch "A" on both Main Landing Gear Forward Side Braces, Piper Part Number 40279-16 left and 40279-17 right for PA-31T2; Piper Part Number 40279-08 left and 40279-09 right for PA-31, PA-31P, PA-31T, and PA-31T1 Models.

NOTE: Installation of new improved main landing gear forward sidebraces will require the use of longer bolts at the main gear retraction arm to sidebrace attach points, see Material Required. Refer to Sketch 'A'.

2. Inspect area for cracks using dye penetrant or zyglo procedures.
3. If cracking is indicated, replace the affected part prior to further flight, per the appropriate aircraft maintenance manual.
4. Make the appropriate logbook entry of compliance with PART I of this Service Bulletin.

1. Refer to the appropriate maintenance manual for specific instructions.
2. Remove main landing gear forward side brace on left and right main landing gear.
3. Install new main landing gear forward side braces. (See Material Required for specific part number).
