SERVICE *No. 967* BULLETIN

DATE: January 24, 1994

Aileron Hinge Inspection and Replacement

PA-31P Pressurized Navajo
PA-31T Cheyenne II

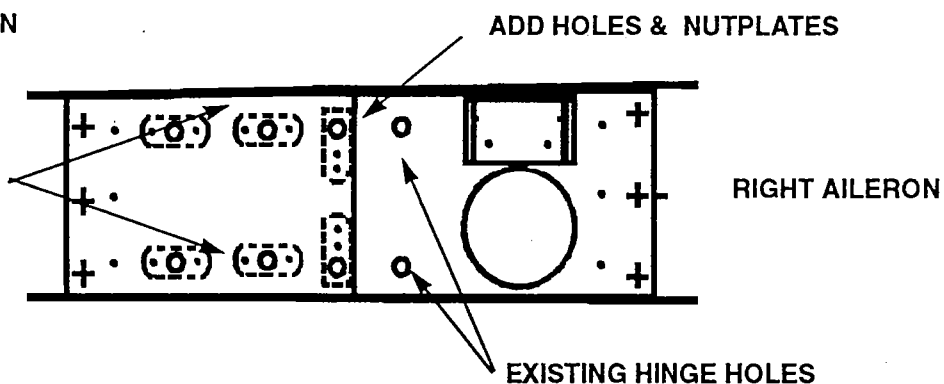
TYPICAL AILERON

Reports have been received indicating that small cracks are developing in the aileron spar and reinforcement doubler beneath the inboard aileron hinge attachment point.

INSPECT:
CRACKS WILL
APPEAR ALONG
SPAR FLANGE
AND AT ATTACH
HOLES.

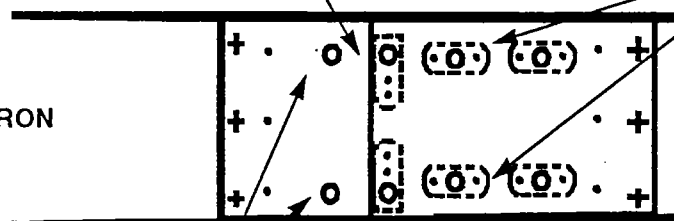
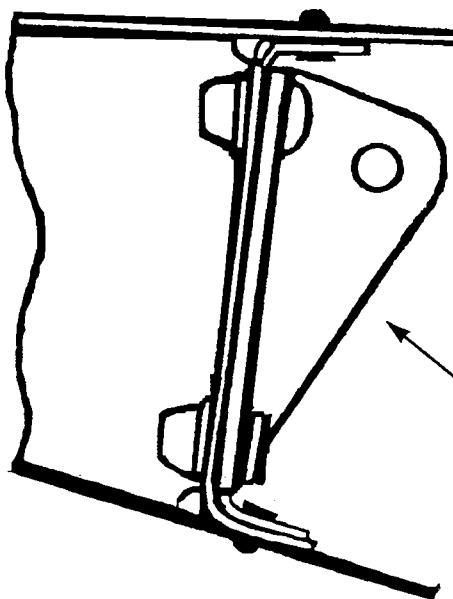
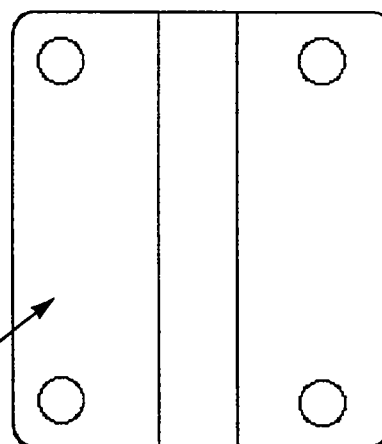
SKETCH A

EXISTING HINGE HOLES

INSPECT:
CRACKS WILL
APPEAR ALONG
SPAR FLANGE
AND AT ATTACH
HOLES.

ADD HOLES & NUTPLATES

INSTALL NEW HINGE
P/N'S 74461-02 (LEFT)
AND 74461-03 (RIGHT)
