SERVICE LETTER

No. 779

Piper Aircraft Corporation

Subject: Heater Fuel Pressure Relief Valve Inspection.

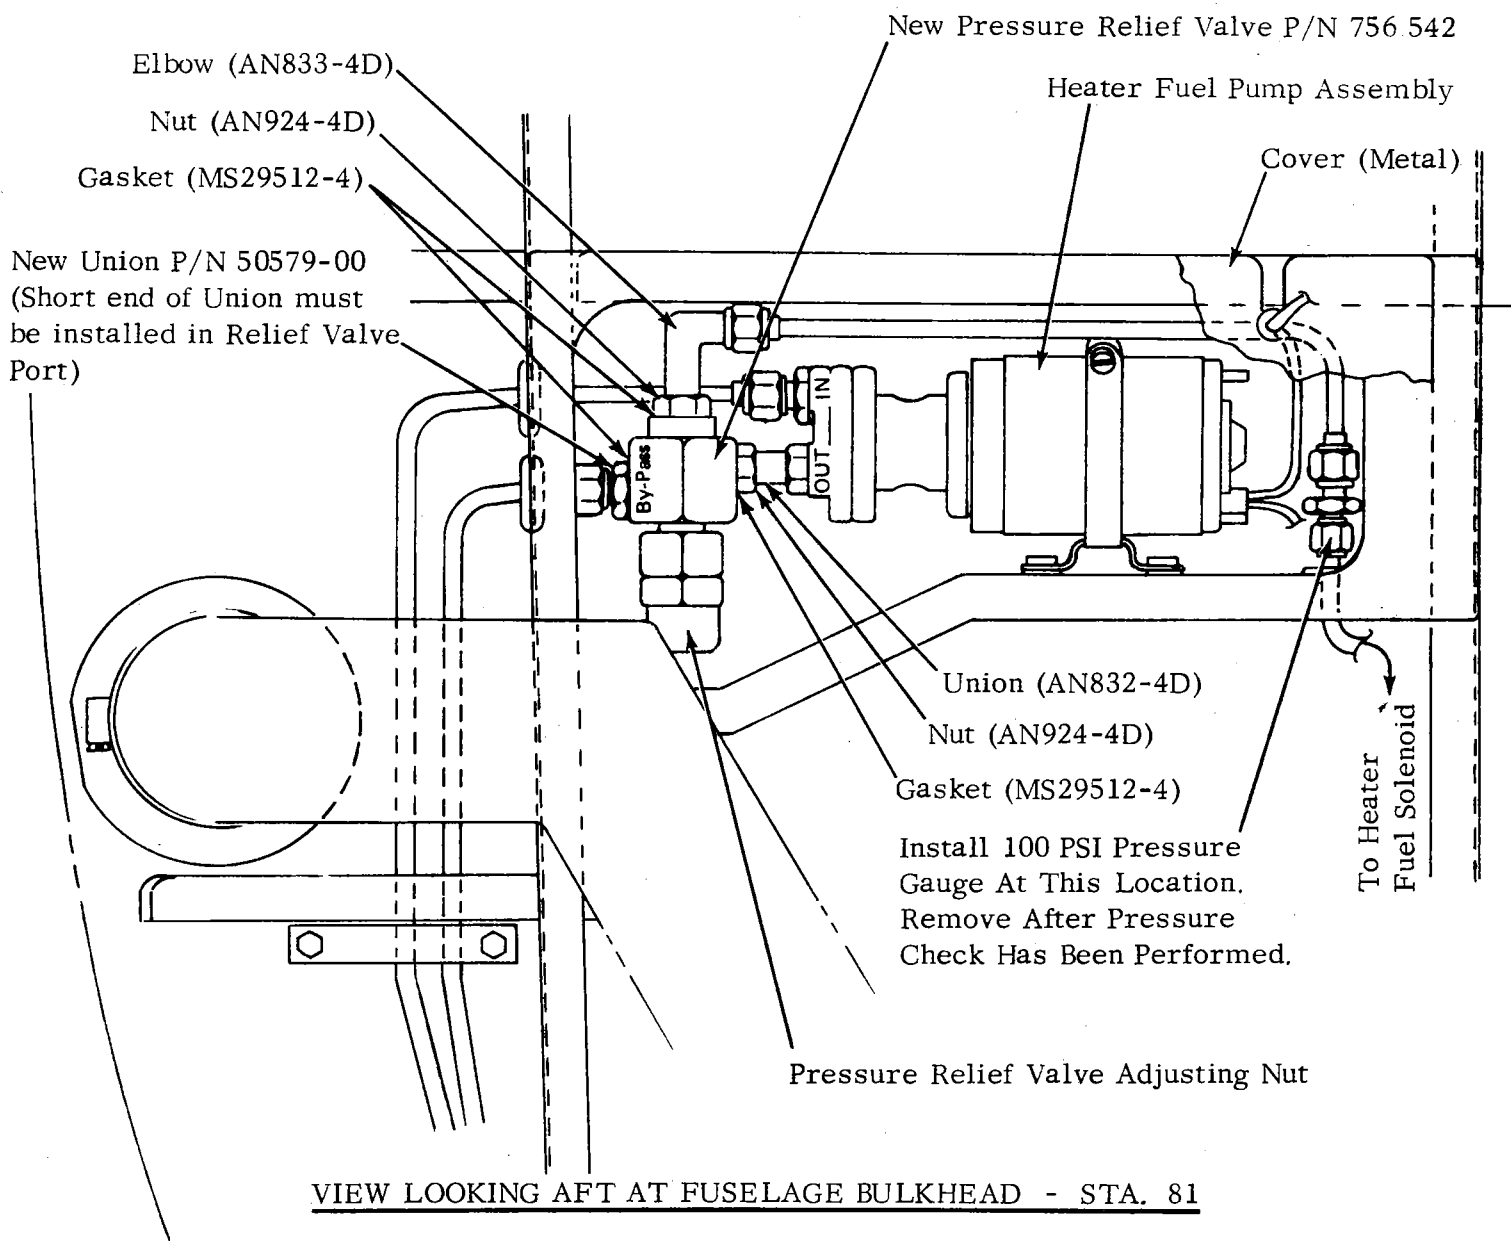
INSTRUCTIONS

A few reports concerning Cheyenne heater malfunctions have been attributed to "coking" of the heater ignitor plug. This condition was traced to an improper union installed in the heater fuel pressure relief valve and/or an improper pressure relief valve setting.

1. Gain access to heater fuel pump and pressure relief valve by removing access panel from right side of fuselage nose section.
2. Remove metal cover from bulkhead to expose pump and valve.

3. Disconnect fuel lines attached to pump and valve.
4. Remove pressure relief valve from fuel pump and disassemble fittings from valve.
NOTE: Discard nipple installed in By-Pass port of valve, and retain balance of fittings for reassembly on new valve.

5. Install short (flat) end of new union, P/N 50579-00, into By-Pass port of new pressure relief valve, P/N 756 542, using existing MS29512-4 gasket.
6. Install balance of existing fittings to new valve and assemble to pump.

7. Connect fuel lines to valve and pump, and tighten.
8. Install 100 psi pressure gauge into line from pressure relief valve to heater fuel solenoid.
9. With an engine fuel boost pump ON and with heater in operation, adjust heater fuel pressure to 100 psi with the pressure relief valve adjusting nut.

10. After adjustment, remove pressure gauge and reconnect heater line.
11. Reinstall metal cover and fuselage access panel.
12. Make proper logbook entry of valve and nipple replacement.
