SERVICE LETTER

No. 783

Piper Aircraft Corporation

Inspection of Air Conditioning System
Capillary Sensor

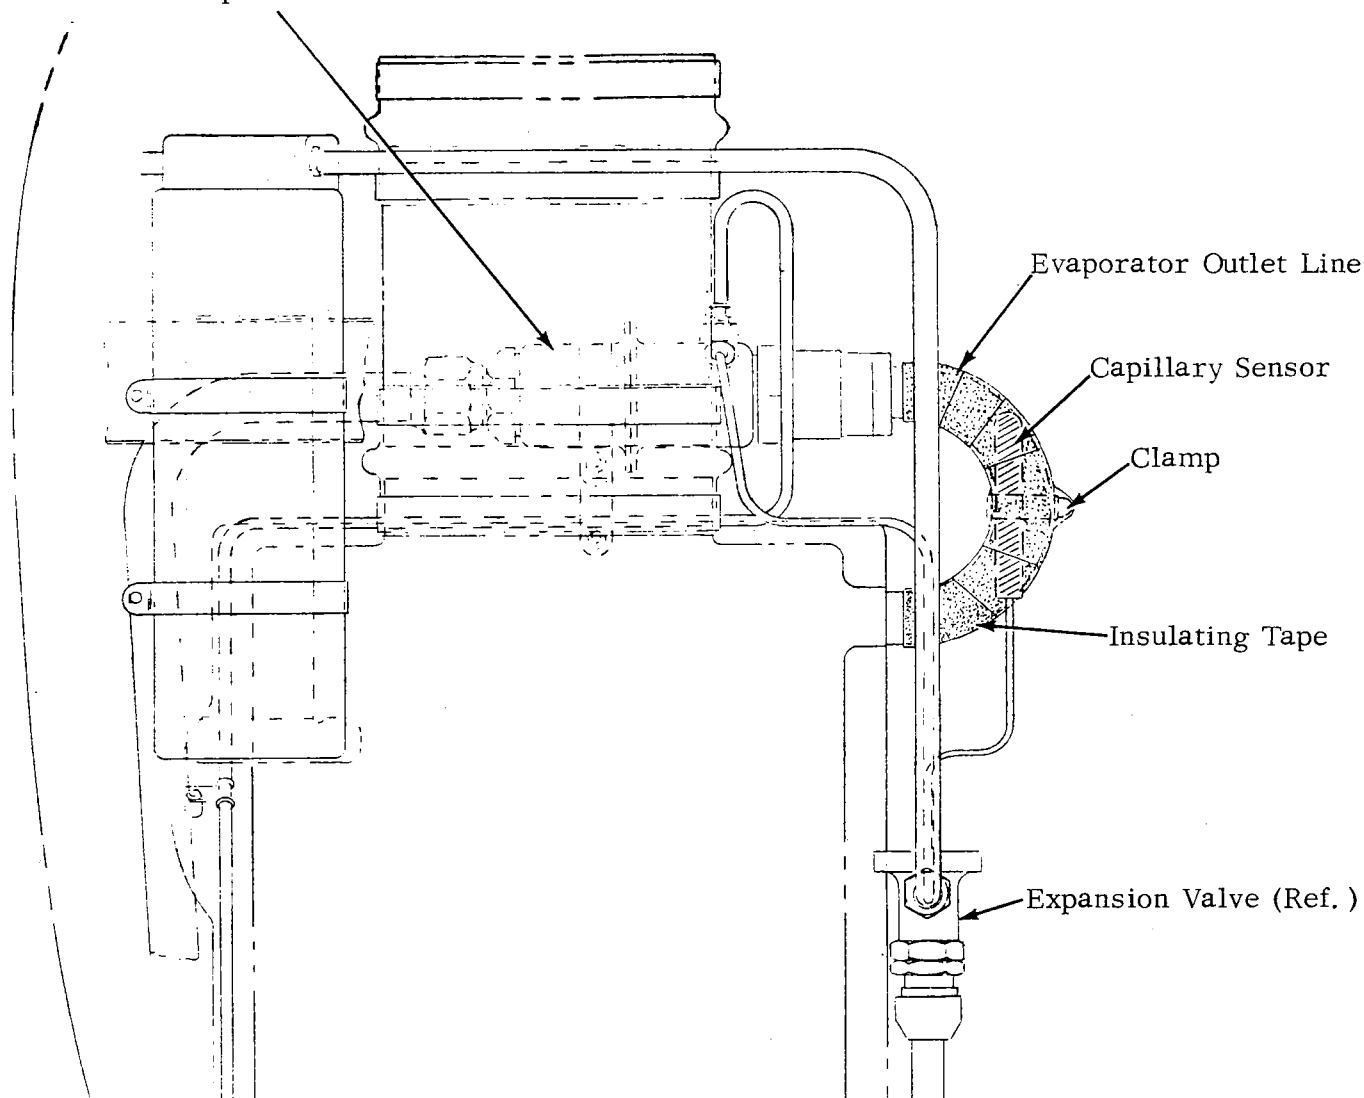
VIEW LOOKING AFT AT EVAPORATOR UNIT

The capillary sensor is a self contained sensing device mounted against the air conditioning system evaporator outlet (from the evaporator to the evaporator control valve) line, to detect the temperature of the system refrigerant. It has been brought to our attention that the capillary sensor may not be securely mounted in its proper position (i.e., under the insulation) on the evaporator outlet line. This condition could cause improper refrigerant temperature readings, with possible system refrigerant exhaustion and/or freon compressor oil starvation.

- a. If clamp is present and capillary sensor does not protrude above the curvature of the evaporator outlet line, no further action is required.
 - b. If clamp is not present and/or if capillary sensor protrudes above the curvature of the evaporator outlet line, proceed as follows.

1. Carefully remove insulating tape from evaporator outlet line and capillary sensor. Clean tape residue from line and sensor using MEK or acetone.
 2. Secure sensor to line, as shown above, using clamp P/N 454 921 (SAE Type 10 or Breeze #QS100-M10).

3. Apply insulating tape P/N 189 777 (P. T. I. Prestite Insulating Tape 1/8" x 2") over outlet line, capillary sensor and clamp.
3. Reinstall access panels and make proper logbook entry of Service Letter 783 compliance.
