SERVICE LETTER

No. 883

Piper Aircraft Corporation

Wing Flap Rivet Installation

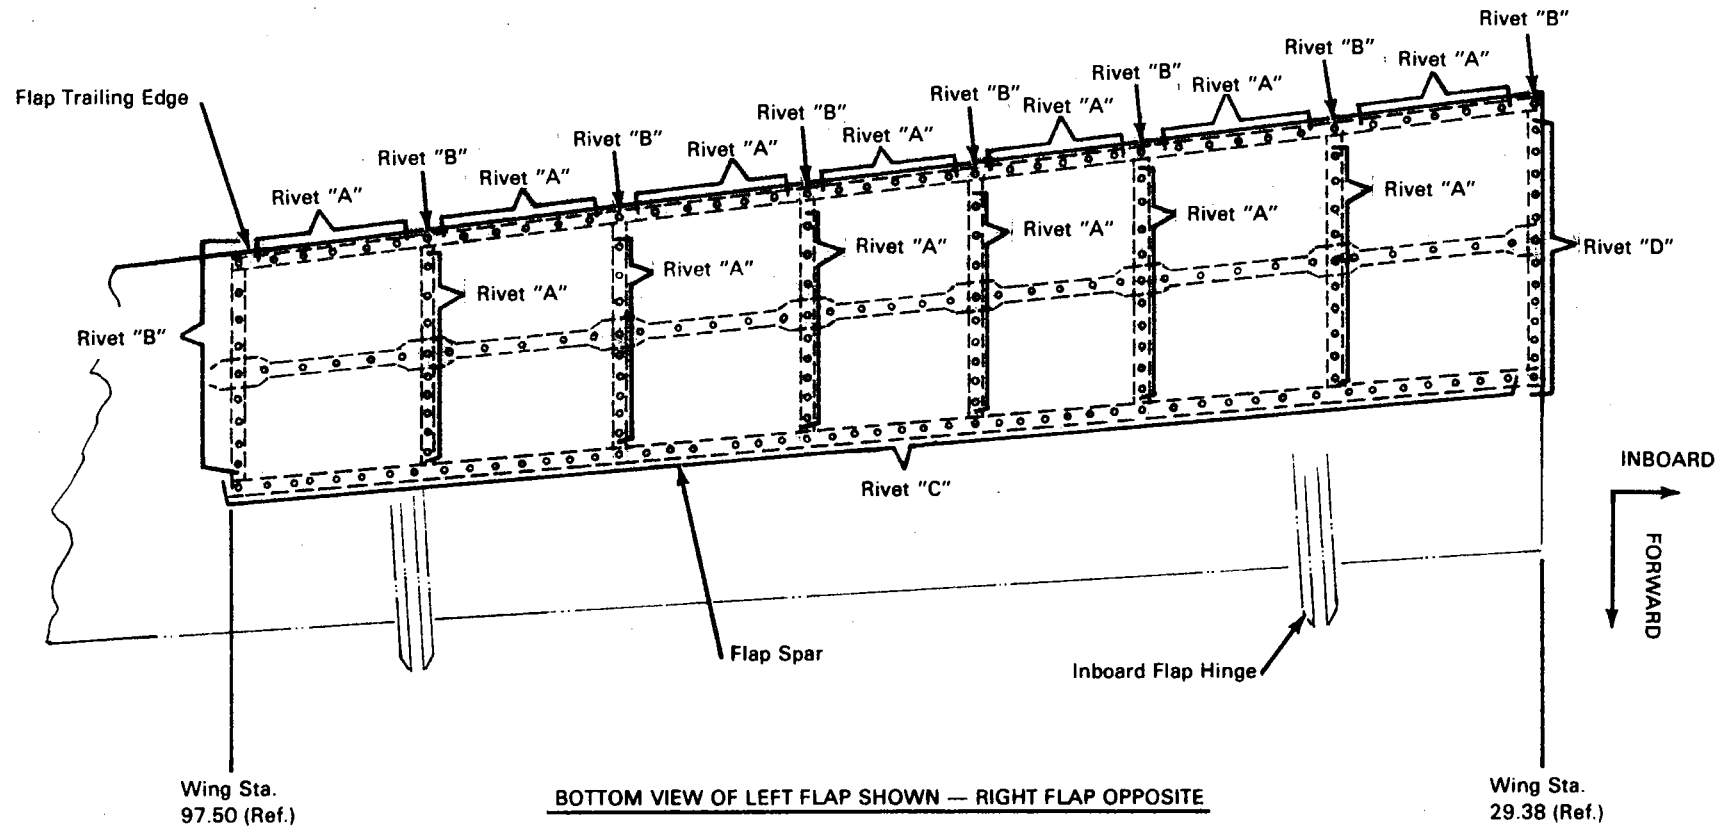
Reports have been received of loose rivets on the bottom surface of the wing flap assemblies. In several instances recurrent loosening of rivets has occurred in aircraft on which loose rivets were replaced.

RIVET	PART NO.
A	NAS1738B-4-1 (P/N 522 881)
B	NAS1738B-4-2 (P/N 522 882)
C	NAS1738B-4-3 (P/N 522 883)
D	MS20470AD3-3 (P/N 420 200)

1. Gain access to the bottom surfaces of the left and right wing flap assemblies.
2. Replace any rivets showing evidence of looseness. Refer to sketch for proper replacement part.
3. On the bottom surfaces of the wing flap assemblies, from and including Wing Station 29.38 to and including Wing Station 97.50 between the flap trailing edge and the flap spar including the flap spar, add appropriate rivets midspace between existing rivets where the distance between the existing rivets is one (1) inch or greater.
4. Make proper log book entry of compliance with this Service Release.
