S.A. 31T-8

February 14, 1983

Subject: Airconditioning Condenser Fan Impeller Replacement

Models Affected: PA-31T3 T-1040

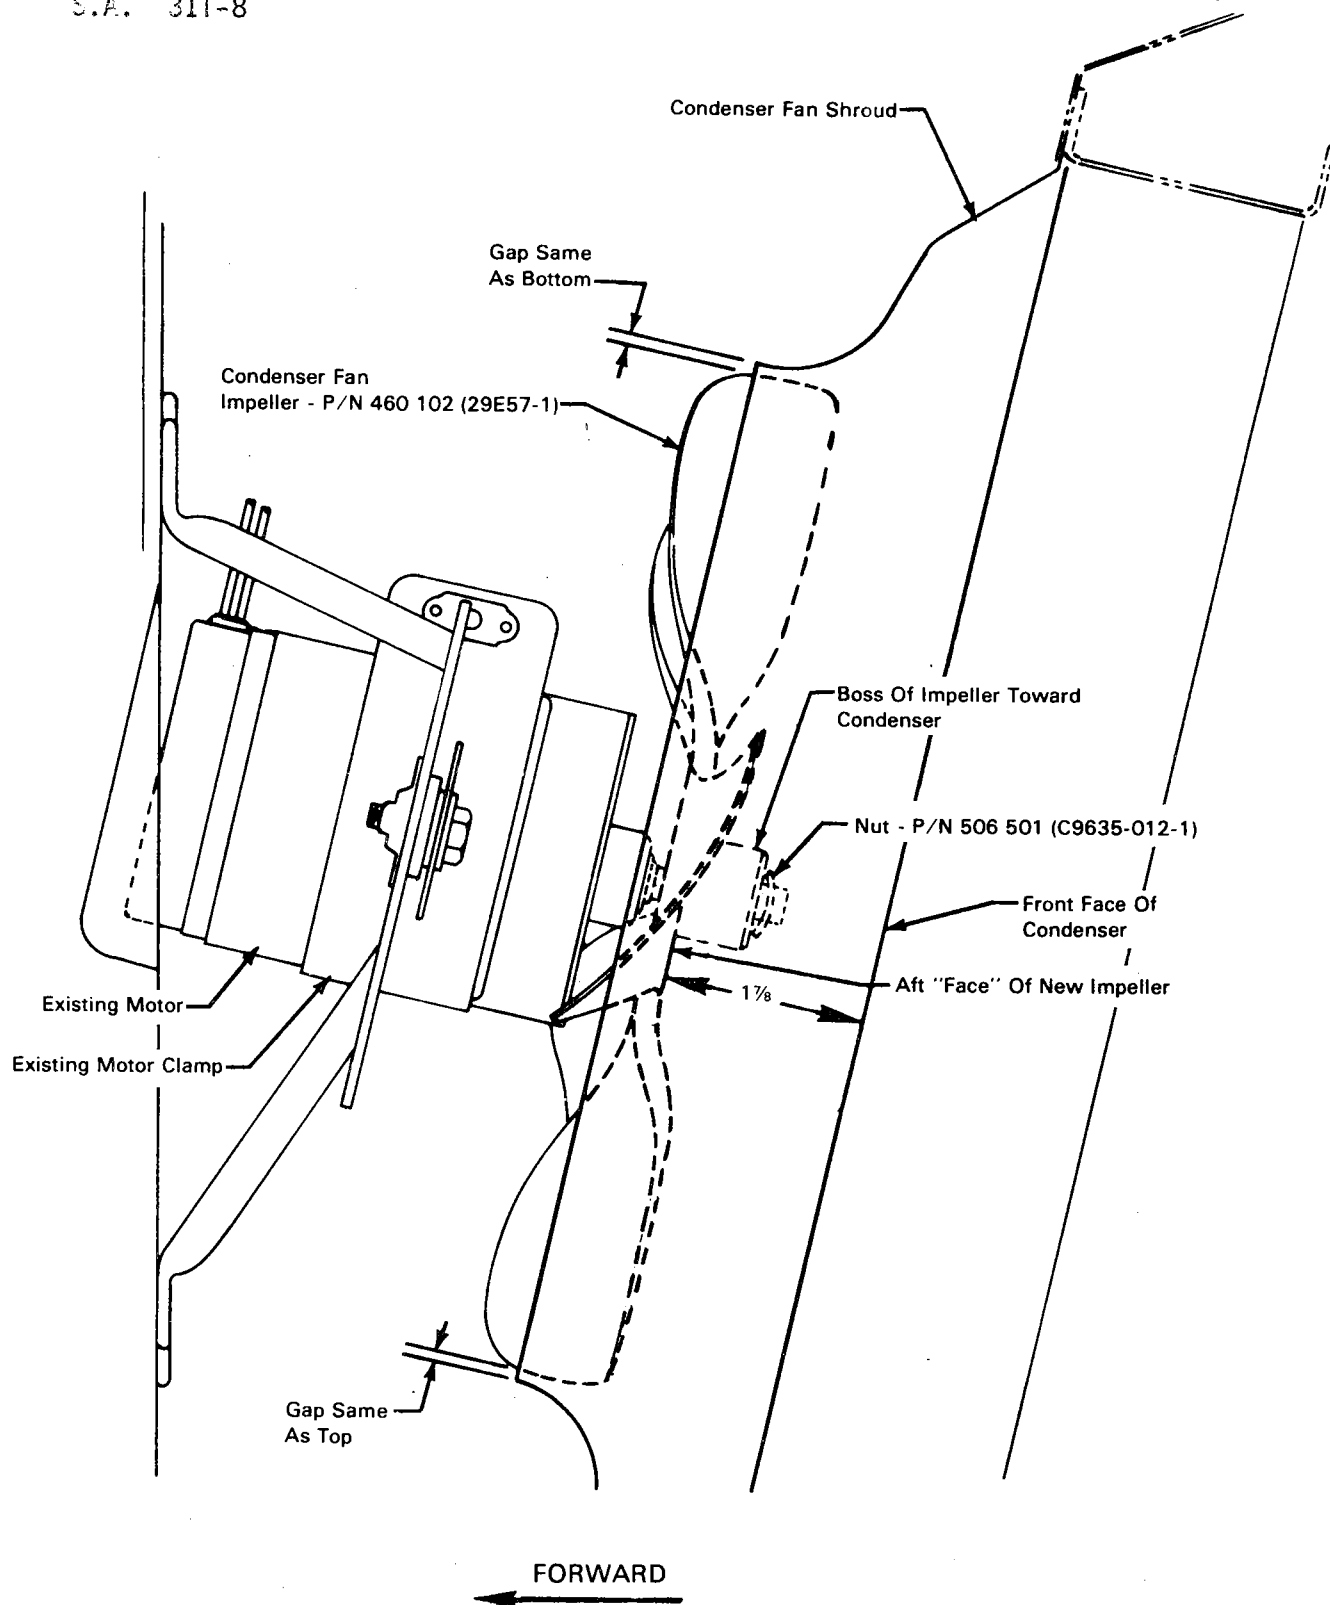
Field reports indicate that a number of Cheyenne I's and II's have experienced failures of the condenser fan impeller, Piper Part Number 55299-02. Due to the similarity of installation in the T-1040 aircraft, it is possible that the affected aircraft may also be susceptible to this problem. Failure of this impeller may cause damage to the condenser and other installations in the vicinity of the fan.

10. Position the impeller on the motor shaft so that aft "face" of the impeller is not less than 1 7/8 inches from the condenser. Make a slip mark on the motor shaft at the impeller's location.

13. Reposition the motor in its clamp back to its originally marked position and tighten the clamp. Make sure the face of the impeller is 1 7/8 inches from the condenser, reposition the motor in its clamp as necessary. Refer to sketch for dimensional reference.
