VSP - 110

SUBJECT: Distribution of: **ALLIEDSIGNAL AEROSPACE Service Bulletin No. 103638-21-4062**
"Cracked Polycarbonate - Plastic Outflow Valve Poppet"

ATA CODE: 2130

AIR CONDITIONING -- Outflow/Safety Valve -- Identification of valves that require replacement

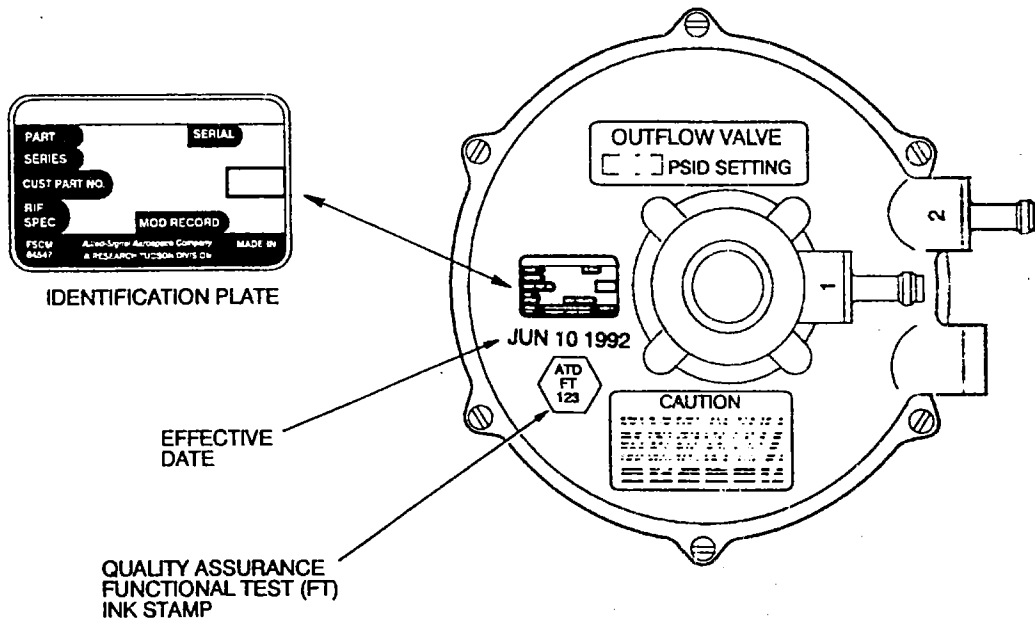
Outflow/Safety Valve Identification Plate
Figure 1

- A. Visually check the valve serial number appearing on the identification plate against the effectivity list. (See figure 1.) If the serial number of the valve appears on the effectivity list, replace valve in accordance with aircraft manufacturers instructions, unless one of the following conditions is satisfied.
- B. If the serial number of the valve appears on the effectivity list, but the identification plate MOD RECORD block contains "PCA," no further action is required and the valve is considered serviceable.
- C. If the serial number of the valve appears on the effectivity list, but the valve cover has an inked ATD Quality Assurance "Functional Test (FT)" stamp dated June 1992, or later, no further action is required and the valve is considered serviceable. (See figure 1.)
- D. Reidentification
