VSP-48A
January 26, 1988

VENDOR SERVICE PUBLICATION

SUBJECT: United Technologies - Pratt & Whitney Canada Service Information Letter No. 1035-13011

Subject: **SULPHIDATION ATTACK**

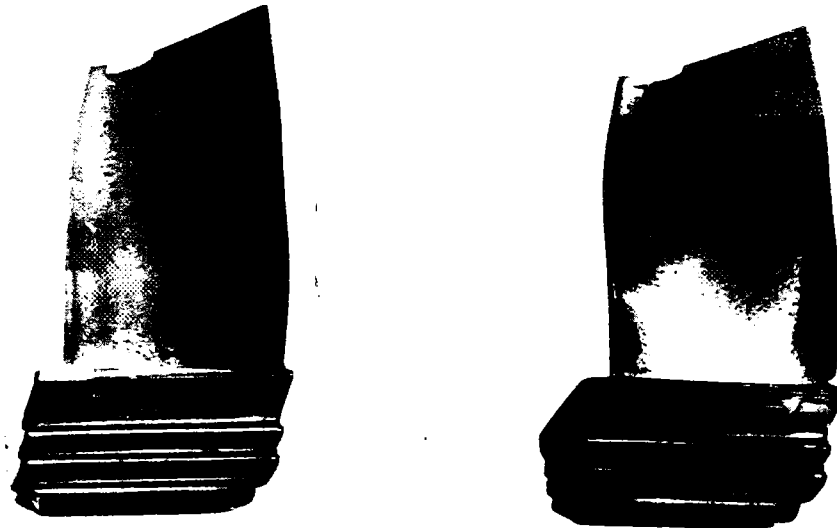
Slight roughening of the surface caused by some growth and localized breakdown of the oxide scale layer is evident. Depletion of chromium in the substrate layer has not started. Mechanical integrity is not affected.

Figure 1, Typical Stage 1 Sulphidation

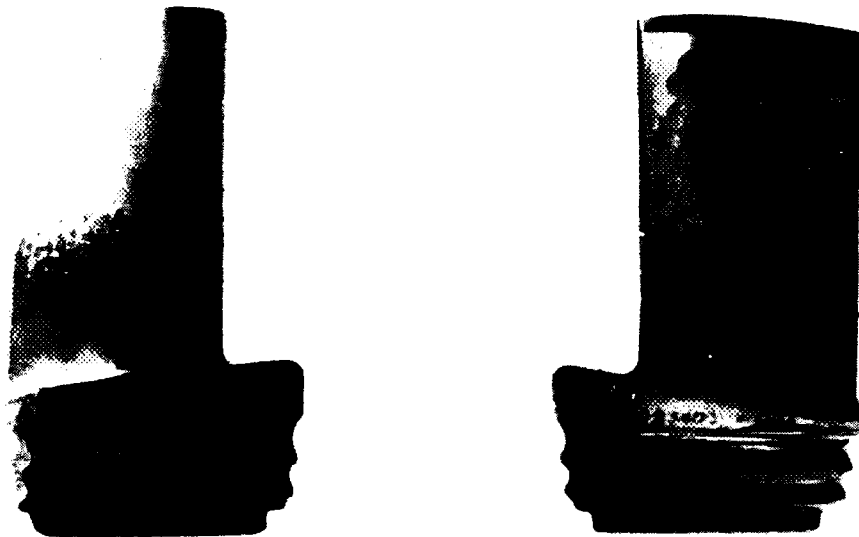
Roughness of surface is more marked as oxide layer breakdown continues. Depletion of chromium from underlying alloy has commenced. Mechanical integrity still not affected.

Figure 2, Typical Stage 2 Sulphidation

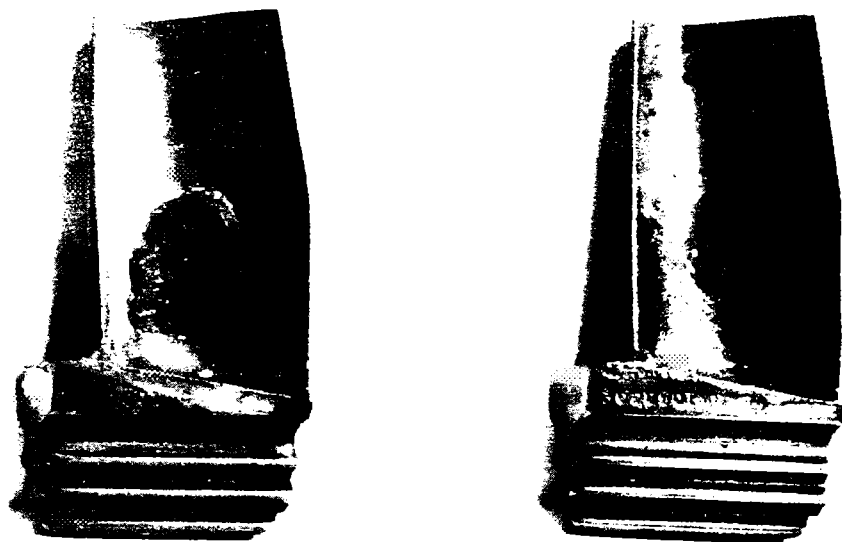
Oxidation of the base material has penetrated to significant depth, with obvious build-up of scale. Integrity seriously affected. Progression to stage 4 will accelerate with or without the continued presence of sodium.

Figure 3, Typical Stage 3 Sulphidation

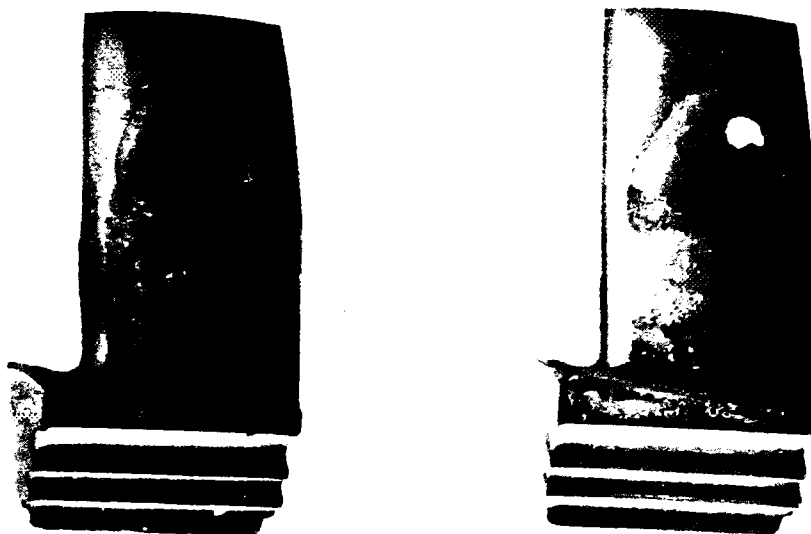
Deep penetration of attack with large "blister" of scale. Failure likely due to loss of structural material.

Figure 4, Typical Stage 4 Sulphidation

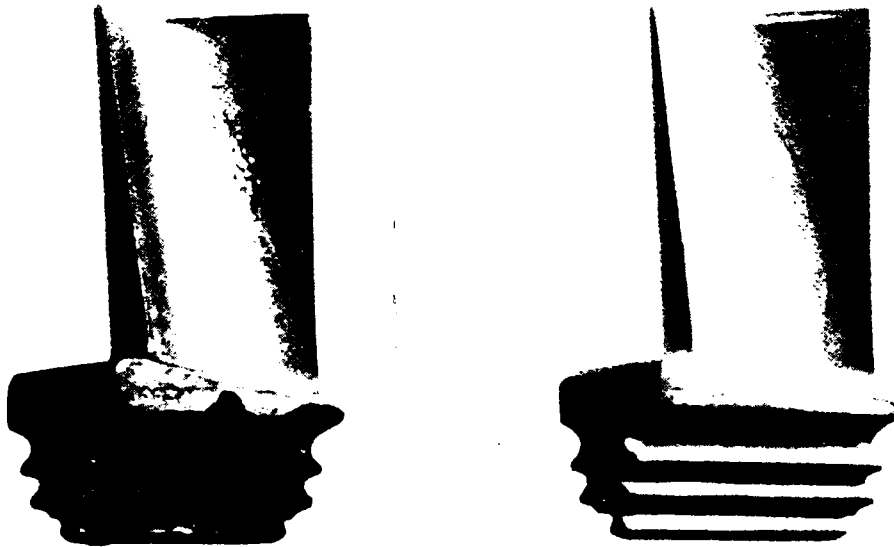
Figure 5, Typical Stage 2 Sulphidation After Coating Strip

It should be noted at this point that the aluminide coating applied to the CT blades incorporates elements of the base alloy in varying amounts throughout, due to the diffusion process. Therefore any degradation of the coating will involve loss of the base alloy to some extent and with the inevitable unevenness of the attack, if stripping and recoating is entertained, it should be understood that a majority of components may be rejected on post stripping inspection. Figure 5 shows typical stage 2 sulphidation after coating strip.
