SERVICE BULLETIN

No. 443

Inspection of Main Fuel Cell Fitting

PA-31 and PA-31-300

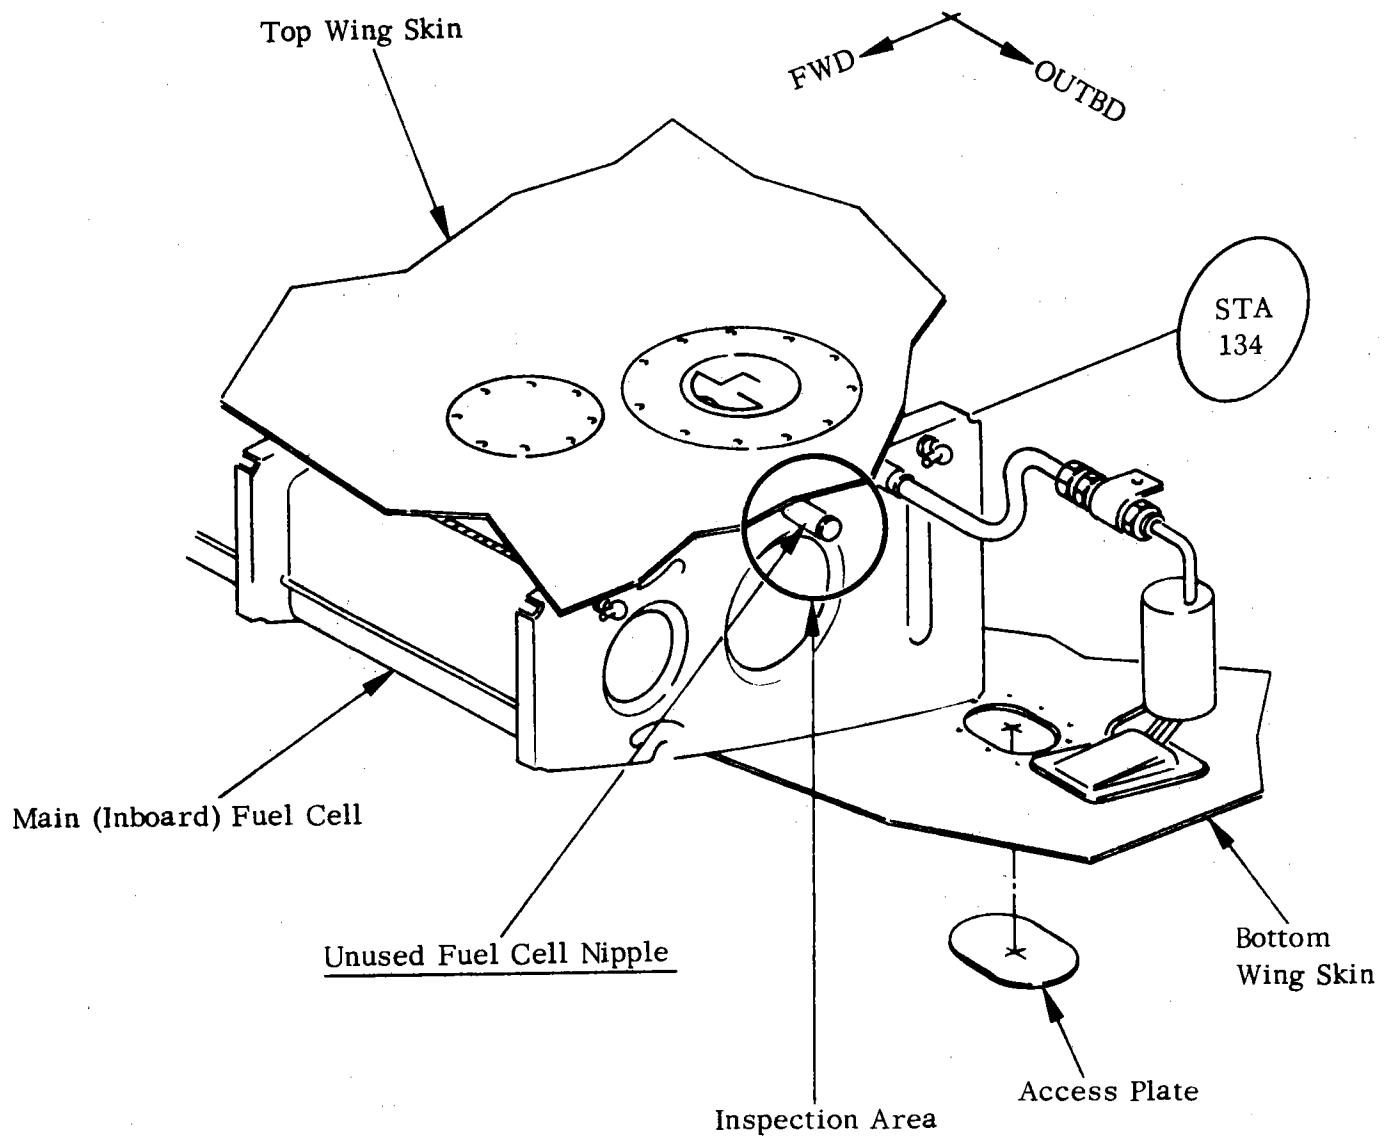
1. Refer to attached sketch/instruction sheet to locate the area of concern.
2. Gain access to the fuel cell area in which the above referenced fitting is located - if installed.

3. Using a flashlight and mirror, check the fuel cells for the presence of the above referenced fitting ("nipple").
4. If the nipple exists, check for indications of fuel leakage at the nipple;
 - a. If no leakage is apparent, install Piper Kit no. 760-929, Fuel Cell Nipple Support. Subsequent to this modification, make appropriate log entry and return aircraft to service.
 - b. If leakage is apparent, replace appropriate fuel cell (ref. Material Required, number 2 below). Make appropriate log book entry and return aircraft to service.
5. If the fuel cell (s) does (do) not contain the subject fitting, no further action is required. Replace inspection plates, etc., make log book entry and return aircraft to service.
