# SERVICE No. 998A BULLETIN

**Elevator Spar Inspection**

PA-31, 31-300, 31-325 Navajo  
PA-31-350 Navajo Chieftain  
PA-31-350 T1020  
PA-31P-350 Mojave

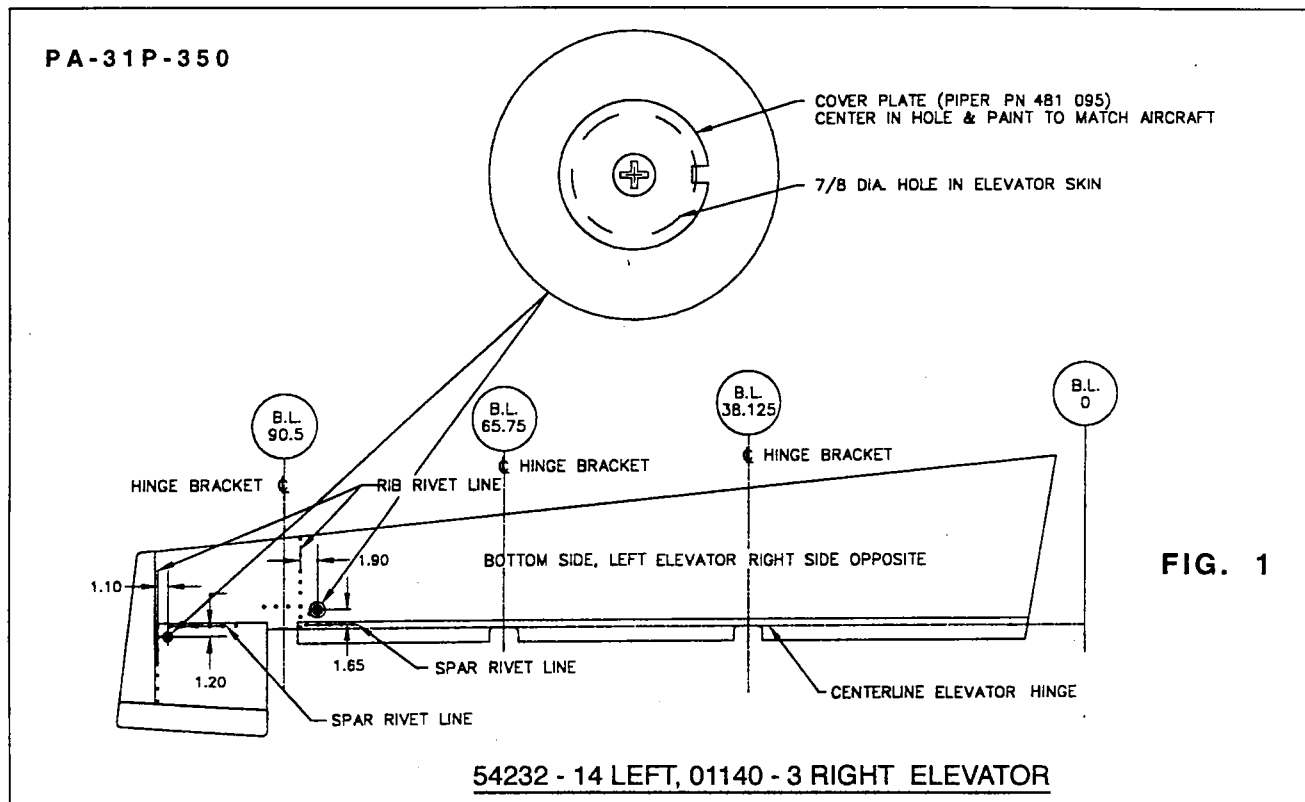
FIG. 1

## SKETCH A

1. Determine the applicable left and right elevator part numbers. Refer to the appropriate Piper Parts Catalog for specific part numbers.
2. Refer to Sketch A or B and use the figure for the left and right elevator which matches the part number determined in Instruction 1 above.

3. Using the dimensions given on the proper sketch and figure, lay out and mark the location for the installation of the two inspection access holes. (**Two** inspection access holes on the bottom of **each** elevator.)
4. Cut a 7/8 inch (2.22 cm) hole using a sharp high quality hole cutter. Do not use a fly cutter.
5. Deburr the hole and touch up the edge with zinc chromate or equivalent paint.
6. Continue with the inspection section below prior to installing the access hole covers.

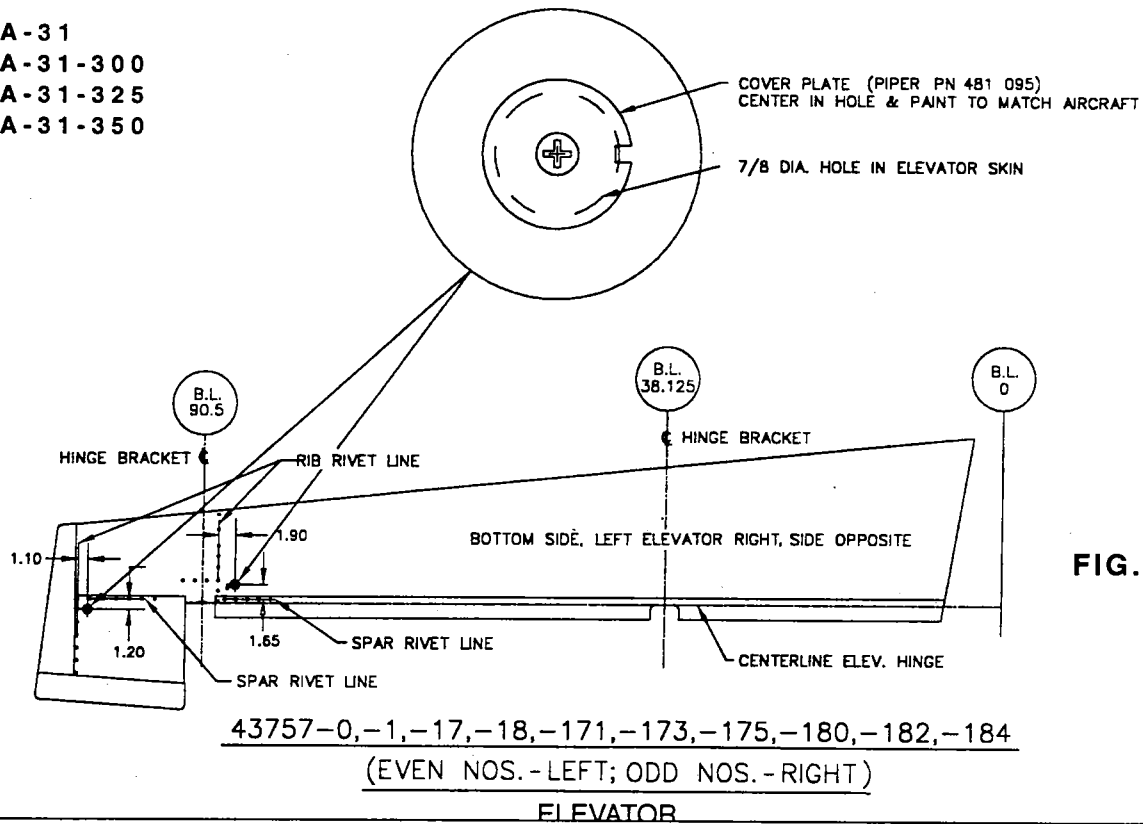
FIG. 3

## SKETCH B

PA-31  
PA-31-300  
PA-31-325  
PA-31-350

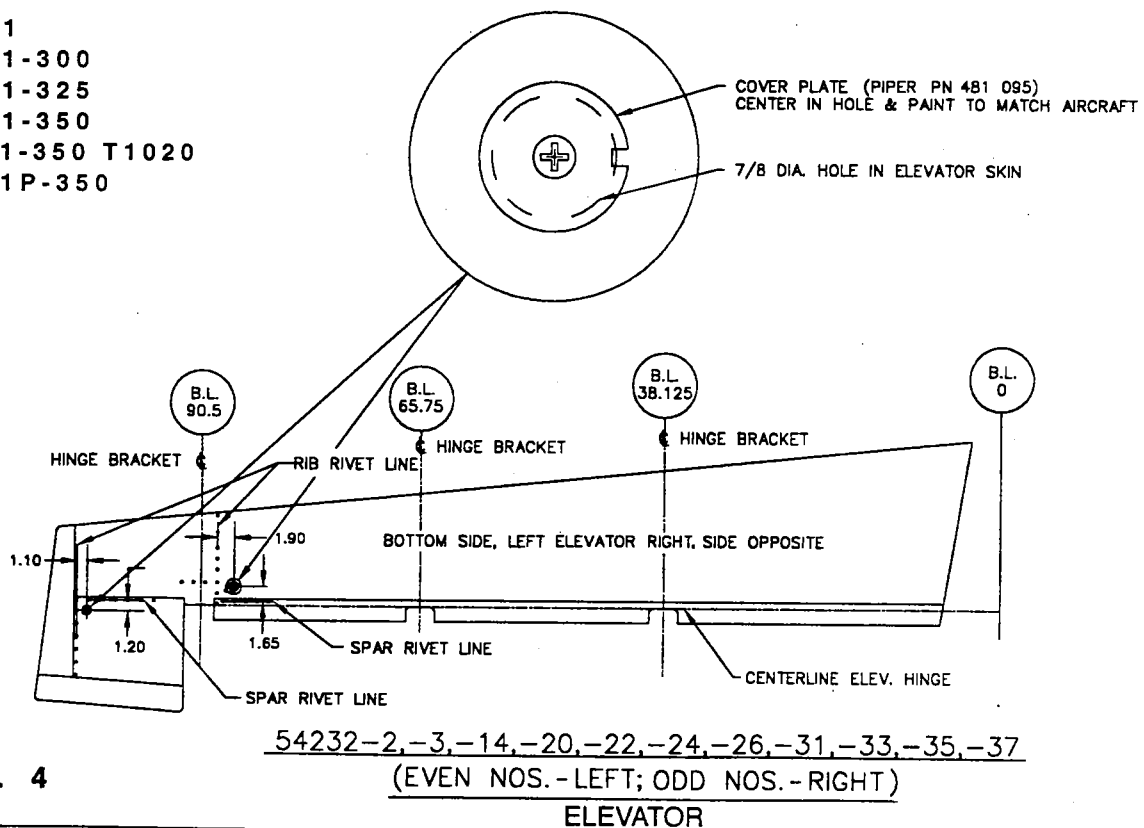
FIG. 4

PA-31  
PA-31-300  
PA-31-325  
PA-31-350  
PA-31-350 T1020  
PA-31P-350

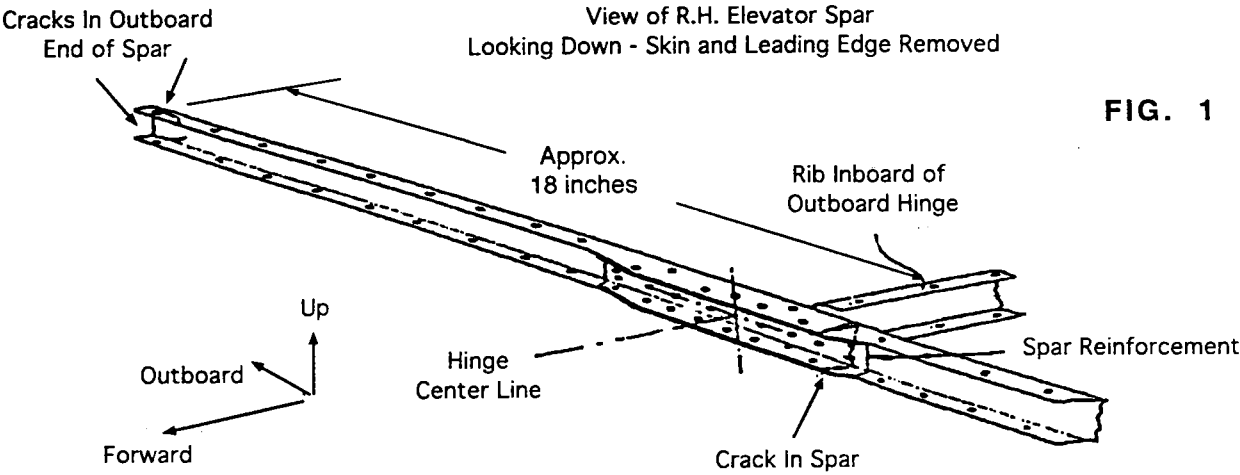
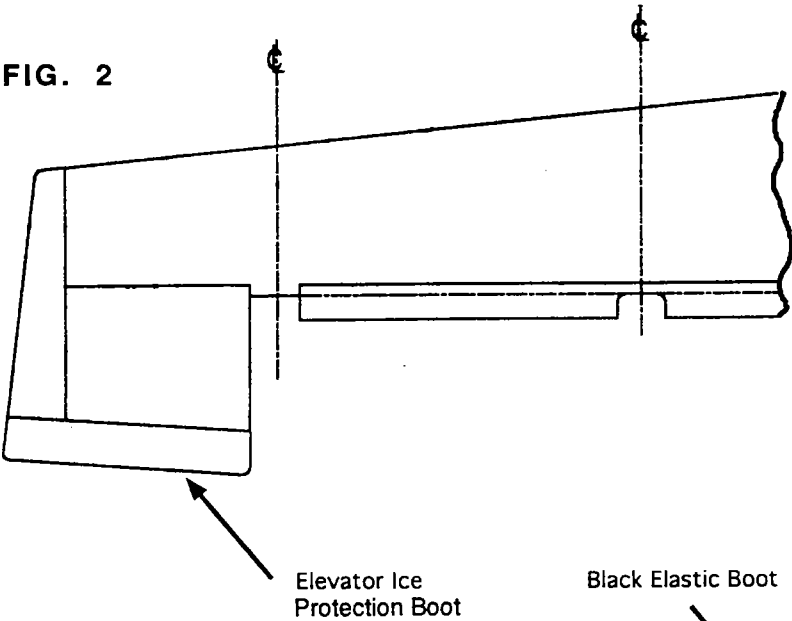
SKETCH C

Reports have been received of small cracks developing in the elevator spar outboard end and at the reinforcement doubler just inboard of the outboard elevator hinge attachment point. The condition is aggravated by poor field installation or maintenance of replacement elevator horn ice protection boots.

**Elevator Spar Inspection:** (Refer to Sketch C Fig. 1)

1. Using a boroscope inspect the area inboard of the outboard hinge on the elevator spar for cracks. If cracks are not observed, continue with these instructions.
2. Using a boroscope inspect the area at the outboard end of the elevator spar for cracks in the flange and cracks that start along the flange bend radius. If cracks are not observed, proceed to Instruction 3.
3. If cracks are not present per Instructions 1 or 2 above, proceed to Instruction 5 below.
4. If the elevator spar is cracked, in either one or both locations as identified in Instructions 1 or 2 above, the elevator spar must be replaced. A new elevator may be installed in lieu of replacing the elevator spar. (See Materials Required Table on page 4)

5. Upon successful completion of the elevator spar crack inspection, install the two cover plates, Piper Part Number 481-095 on each elevator.

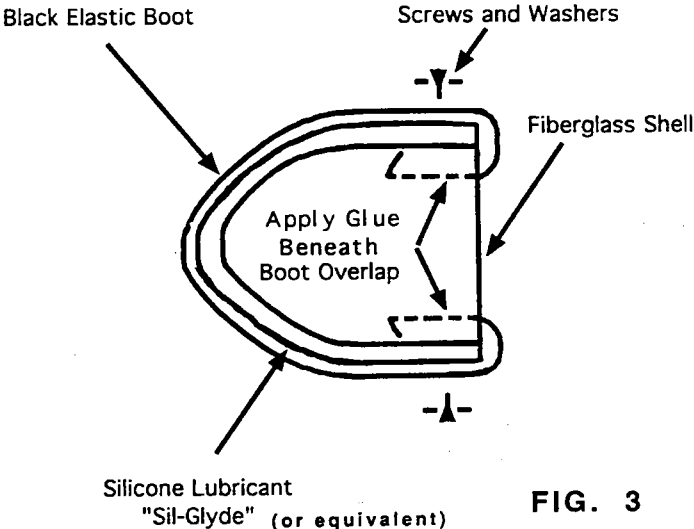
**INSTRUCTIONS:** (CONT'D)**Elevator Ice Protection Boot Inspection and Installation:** (Refer to Sketch C Fig.2)

1. Locate the flexible boot (required installation on all PA-31 series aircraft) installed on each elevator horn tip and examine it for general condition. If the boot is torn, damaged, deteriorating, or in any manner unfit, the boot must be replaced. (Piper P/N 44322-02.)

2. If the boot is loose but otherwise in serviceable condition the boot must be tightened. Looseness may be defined by the condition where the boot may be pulled up off the underlying surface or pinched between the fingers.

3. Remove the screws and washers retaining the boot assembly and remove. The assembly consists of an elastic boot and a fiberglass shell.
4. Remove and discard the old boot. Clean the fiberglass edge of old glue and silicone lubricant. Generally clean and prepare the fiberglass tip for the boot installation.

5. Try the new boot over the fiberglass tip with the shiny side out. The boot should fit snugly with no wrinkles.
6. With the new boot fit, but prior to the addition of silicone, follow the glue manufacturers instructions and glue one edge of the boot to the inside edge of the fiberglass tip using 3M 1300L glue (or equivalent). Let the glue cure. Carefully fold back the boot and spread a very thin coat of silicone lube such as Sil-Glyde or Dow Corning DC-4. Do not allow the silicone to contaminate the remaining edge of the boot or the inside edge of the fiberglass tip to be glued.

7. Glue the remaining edge of the boot so there is no evidence of wrinkles or looseness. (A soft edge clamp should be used to hold glued edge in place to cure.) *Note: A loose boot in good condition may use the above instructions.*

8. Install the tips onto the elevator. Care must be taken when installing the screws so the new boot is not torn.
9. If a new boot is installed or an existing boot re-installed, make an appropriate log book entry.
