SERVICE BULLETIN

No. 739

Piper Aircraft Corporation

Restriction of Flap Travel and Inspection
of Wing Flap Flexible Drive Shaft

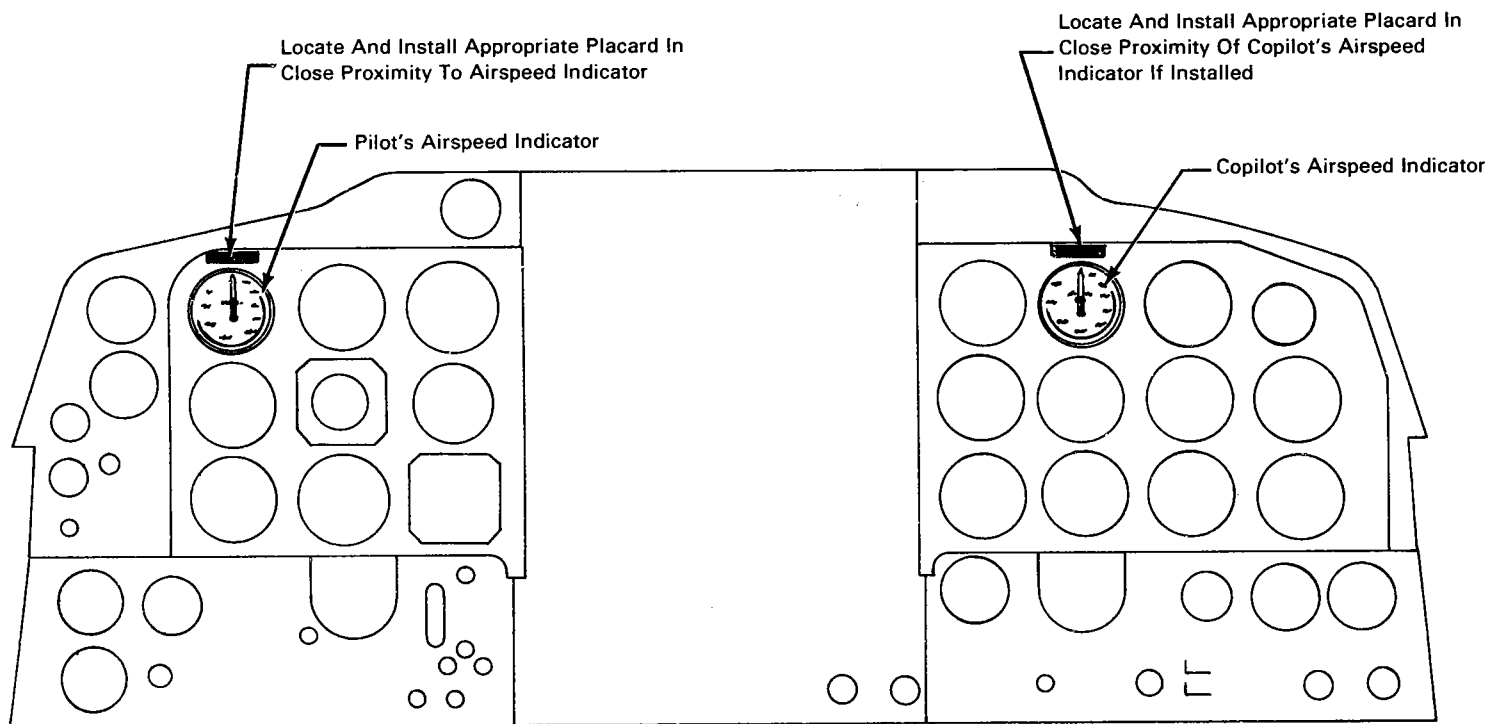
SKETCH B

FLAP SETTINGS IN EXCESS OF 25° ARE NOT APPROVED.
DISENGAGE THE AIRCRAFT AUTOPILOT PRIOR TO
OPERATING FLAPS.
OPERATE FLAP CONTROL IN SMALL INCREMENTS TO
ASSURE FLAP SYMMETRY.

Cut Out And Attach Placard P/N 71859-2 To Pilot's Window Moulding
As Shown In Sketch Above.

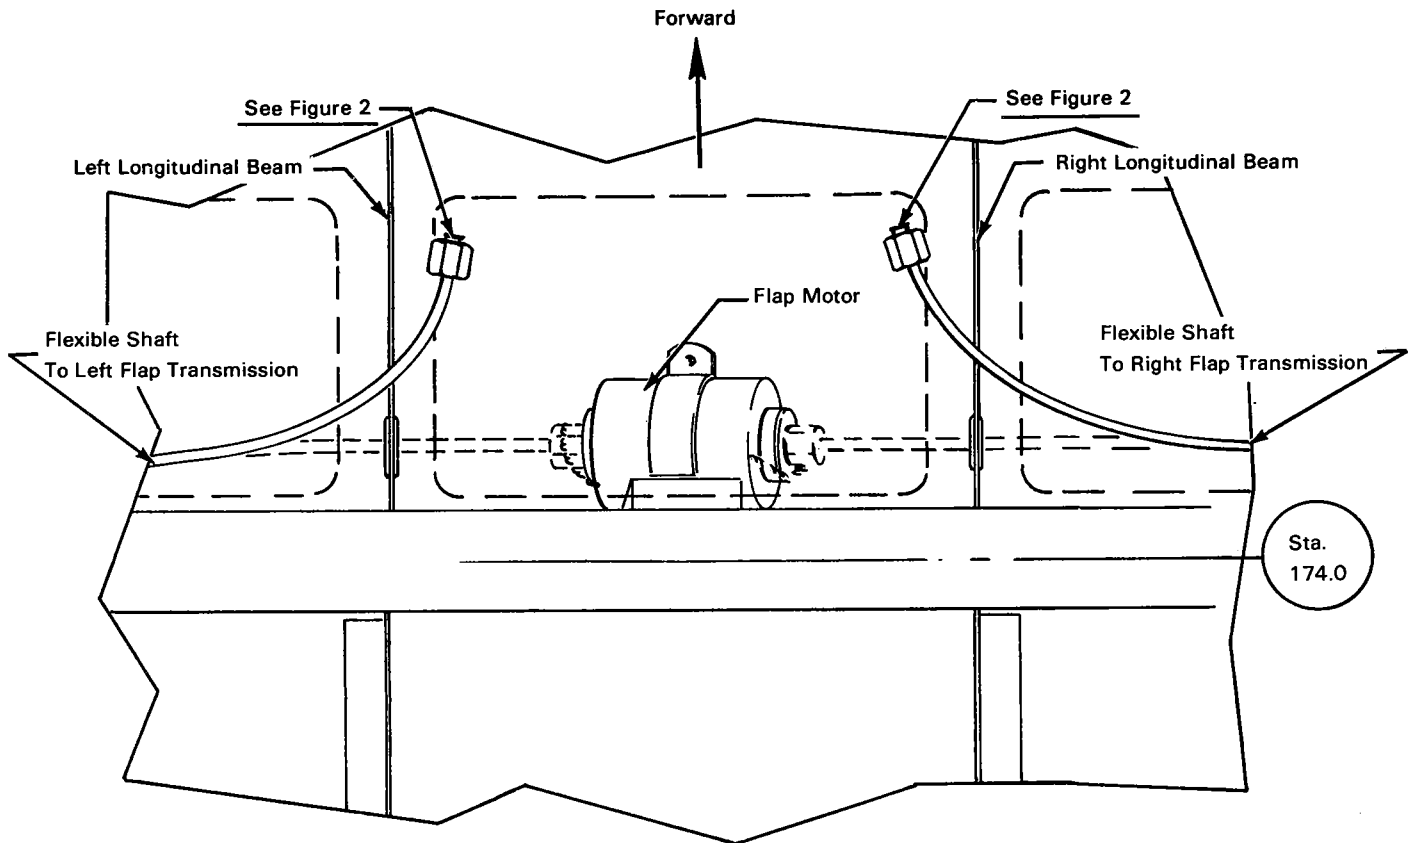
FIGURE 2

4. Visually inspect the flexible shaft splined drive coupling and retaining pin for evidence of looseness on the cable swage fitting. (Ref Sketch D, Figure 2.) If any looseness is apparent, replace the flexible shaft assembly.

5. Inspect the swaged fittings at both ends of the flexible shaft as follows:
 - a. Expose the swaged portion of the inner cable at the motor end by twisting the outer housing two (2) turns clockwise. The swaged portion of the cable should have eight (8) flats clearly visible and free from deep scratches or wear marks. (Ref Sketch D, Figure 2.)

5. Inspect the swaged fittings at both ends of the flexible shaft as follows:
 - a. Expose the swaged portion of the inner cable at the motor end by twisting the outer housing two (2) turns clockwise. The swaged portion of the cable should have six (6) or eight (8) flats clearly visible and free from deep scratches or wear marks. (Ref. Sketch D, Figure 2.).

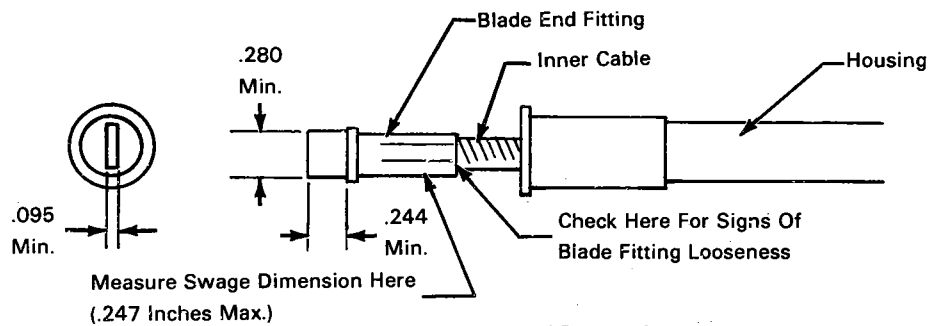
FIGURE 4

- c. Disconnect drive shaft from the flap transmission. Using caution not to damage the shaft housing, route inboard through the Sta. 87.50 bulkhead. (ref Sketch E.) Inspect the swaged portion of the drive blade fitting end as described in "a" and "b" above.

- d. Inspect the drive blade dimension as shown in Sketch E, Figure 4.

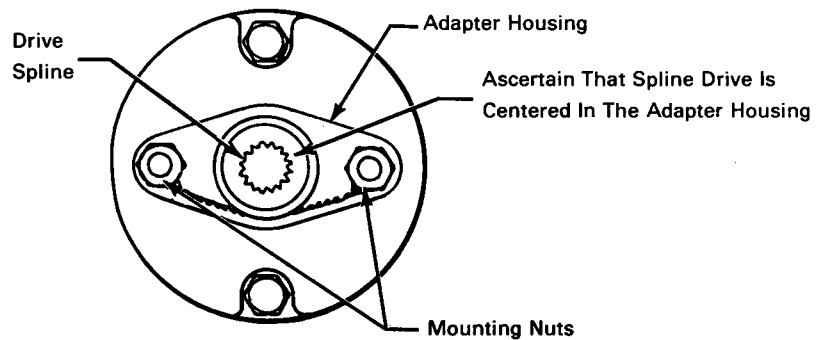
**FIGURE 6**

8. Determine that the inner cable moves freely within the housing, and may be turned easily by hand. If there is any snagging or binding the cable must be replaced.
9. Reassembly of the flap system:
 - a. Ascertain that the flap motor shaft is centered within the motor adapter housing (Ref Sketch F, Figure 6.).
 - b. Lubricate both ends of the flexible shafts with MIL-G-23827 grease.
 - c. Reassemble and verify flap system rigging as outlined in the Surface Controls section (Chapter 5) of the appropriate Service Manual.
10. Reinstall floorboards and access panels.
11. Log compliance with Piper Service Bulletin No. 739, PART II, in the Aircraft Logbook.
