SERVICE LETTER

879

Piper Aircraft Corporation

Subject: Razor Inverter Replacement

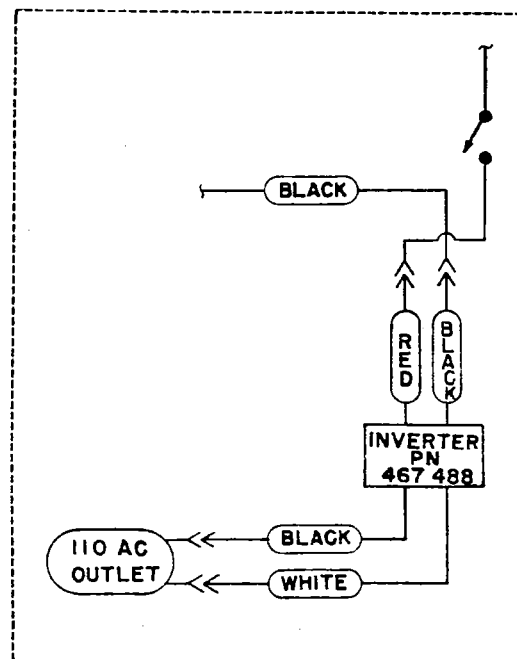
FIGURE 3

In aircraft with an aft cabinet razor inverter, there is a possibility of ADF interference which can result in ADF needle oscillation with the razor outlet switch turned "ON".

1. Gain access to Razor Inverter (Refer to attached sketch).
2. Remove existing Inverter (Piper Part Number 467 145).
3. Install new Inverter (Piper Part Number 467 488).
4. Inspect and insure cabinetry is secure.
5. Make appropriate logbook entry of compliance with this Service Release.
