VSP-30
May 20, 1981

VENDOR SERVICE PUBLICATION

Subject: Bendix Service Bulletins 599A, 609A, 610,
613, 614

SERVICE BULLETIN NO. 599A
(Supersedes Service Bulletin No. 599)
Engineering Aspects are
FAA Approved

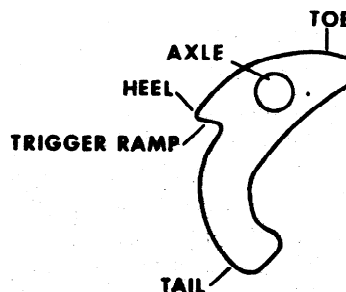
Figure 1. Terminology

- a. Bend the end of a stiff wire into a right angle 1/8 inch long, maximum.
- b. Position impulse coupling so that heel of flyweight (see figure 1) is adjacent to stop pin. Reach

between cam and flyweight with bent wire, as near as possible to the stop pin, and pull outward on the flyweight as shown in figure 2.

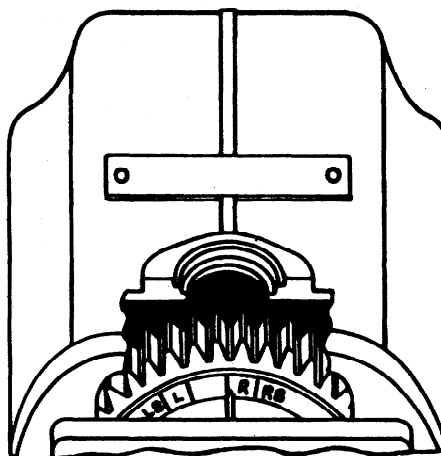
Figure 3. Alignment of Timing Marks on Distributor Gear – 6 Cylinder, Single Breaker, Right Hand Rotation

- b. "6" Cylinder, single breaker types – The timing rib on the distributor block MUST lie between the "L" and "LB" or the "R" and "RB" marks on the gear, and should be nearer to the "L" or "R" mark, depending on magneto rotation. (See figure 3)

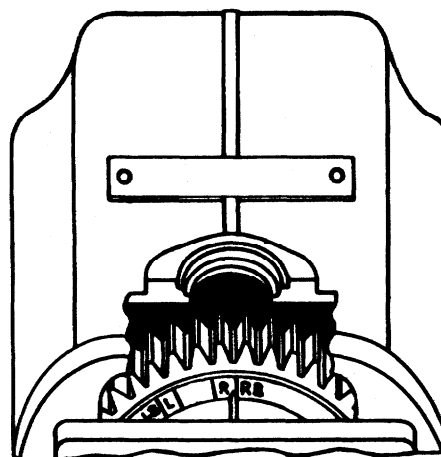
Figure 4. Alignment of Timing Mark on Distributor Gear – 6 Cylinder, Retard Breaker, Right Hand Rotation

- c. "6" Cylinder, retard breaker types – The timing rib on distributor block MUST lie between the "L" and "LB" or the "R" and "RB" marks on the gear, and should be nearer to the "LB" or "RB" mark, depending on magneto rotation. (See figure 4)

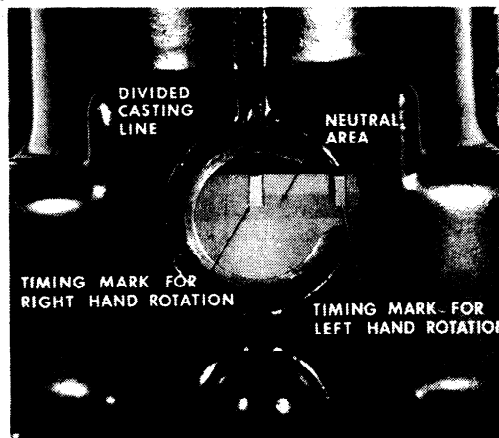
Figure 2. Alignment of Magnet Marks — Right Hand Rotation

- b. Continue turning the engine slowly, still in the direction of normal rotation, until the proper timing mark on the rotating magnet is centered in the viewing hole. Figure 2 illustrates the timing mark centered for a right hand rotation magneto. A left hand rotation magneto would have the left hand mark centered. (See figure 2.) Eight cylinder magnetos will show an "R" line or an "L" line on the rotating magnet.

one cylinder firing position until proper timing mark on rotating magnet is in the center of the viewing hole. (See figure 2.)

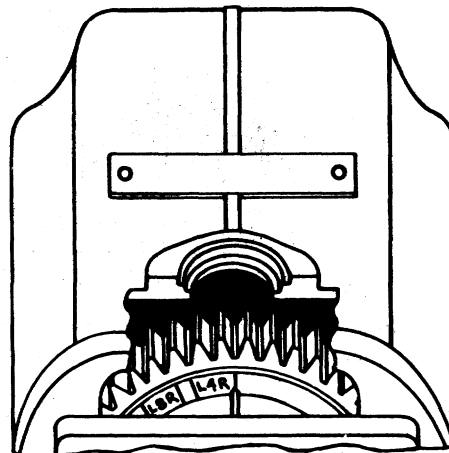
Figure 3. Alignment of Timing Marks on Distributor Gear — 4 Cylinder, Right Hand Rotation

6. Check at top timing hole in magneto to determine if the proper mark on the distributor gear aligns with the timing rib on the distributor block. Alignment tolerances are as follows:
 - a. Four and eight cylinder, all types — The timing rib on the distributor block MUST align within 1/2 tooth either side of the "L" or "R" mark on the gear, depending on magneto rotation. (See figure 3.)

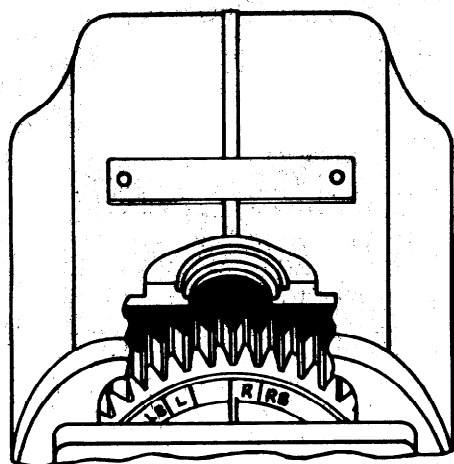
**Figure 4. Alignment of Timing Marks on Distributor Gear —
6 Cylinder, Single Breaker, Right Hand Rotation**

- b. Six cylinder, single breaker types — The timing rib on the distributor block **MUST** lie between the "L" and "LB" or the "R" and "RB" marks on the gear, and should be nearer to the "L" or "R" mark, depending on magneto rotation. See figure 4.

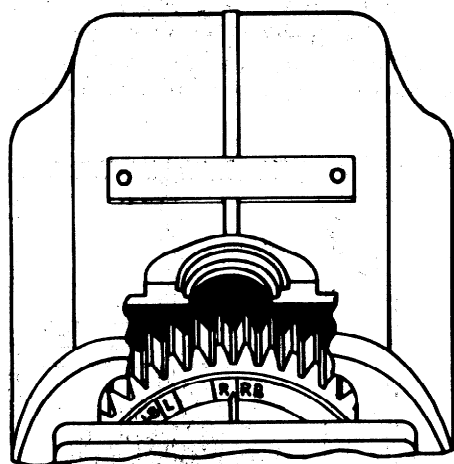
**Figure 5. Alignment of Timing Marks on Distributor Gear —
6 Cylinder, Retard Breaker, Right Hand Rotation**

- c. Six cylinder, retard breaker types — The timing rib on the distributor block **MUST** lie between the "L" and "LB" or the "R" and "RB" marks on the gear, and should be nearer to the "LB" or "RB" mark, depending on magneto rotation. (See figure 5.)
