Piper Aircraft Corporation
Lock Haven, Pennsylvania, U.S.A.

SERVICE *No. 277* BULLETIN

Subject: Fuel Selector Lever Cable Attachment Assembly

Models Affected: PA-31, PA-31-300 Navajos

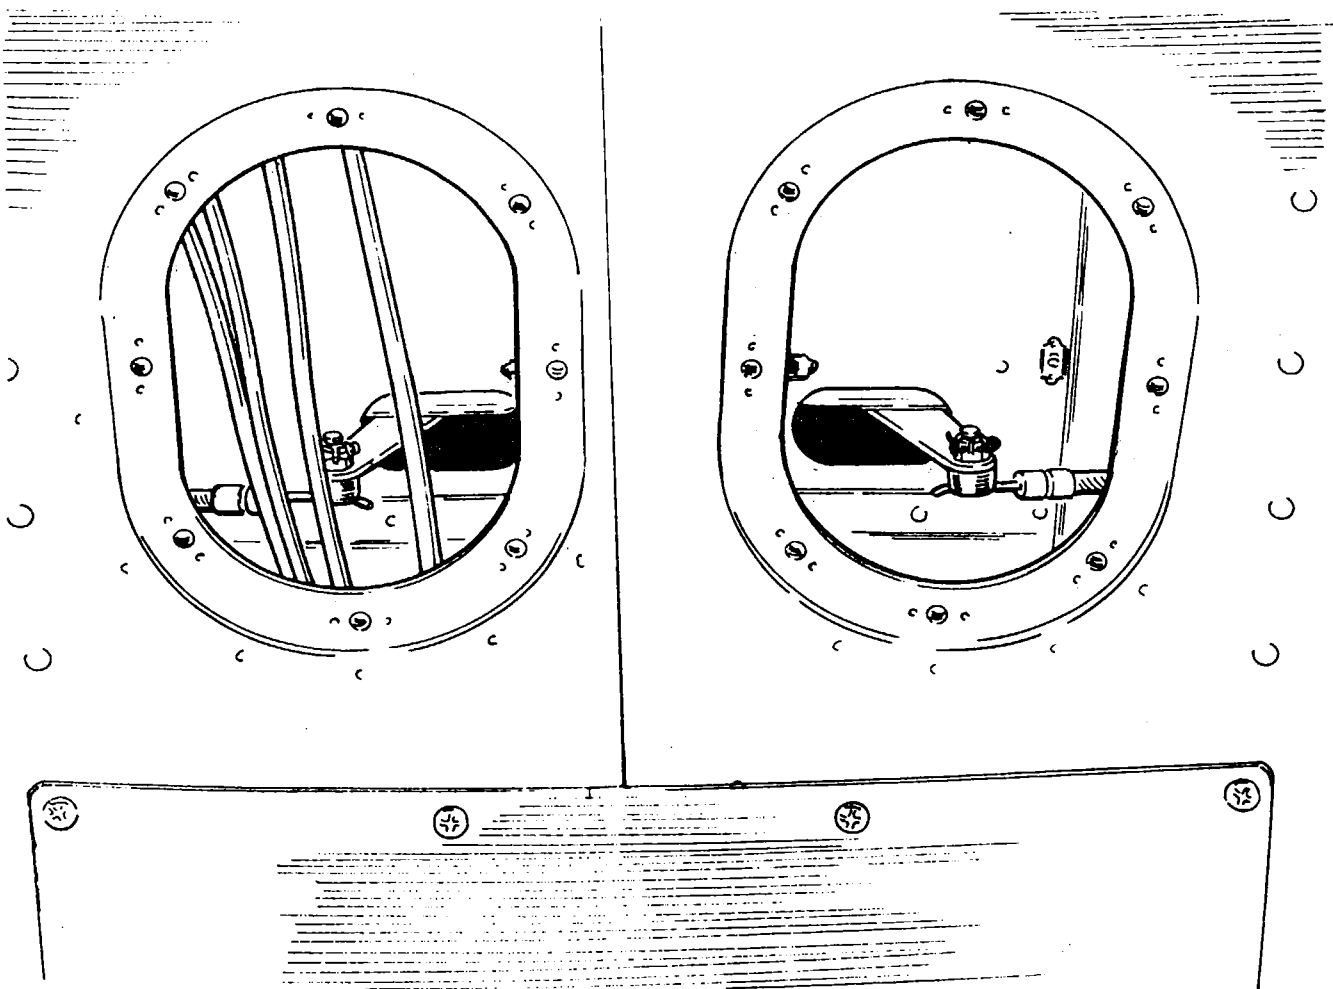
Instructions: Remove the two inspection covers located below the fuel selector control panel on the fuselage belly center-line at station 135 (see sketch on reverse side of this bulletin). Disconnect the push-pull control wires from the fittings, and insert a test wire (approximately .074 inch diameter) in lieu of the control wire that has just been removed, retighten, and rotate the fitting. If both (right and left) fittings rotate freely, reconnect the control wire and check for proper rigging. No further action is required.

If one or both fitting(s) do not rotate freely, kit(s) number 760 214 must be installed.

One (1) each kit no. 760 214 contains instructions and sufficient material for the replacement of one only swivel fitting and push-pull control wire. If both right and left assemblies must be replaced, two (2) each kit no. 760 214 are required.
