SERVICE BULLETIN

No. 682

Piper Aircraft Corporation

Main Landing Gear Inboard Door Hinge
Inspection/Replacement

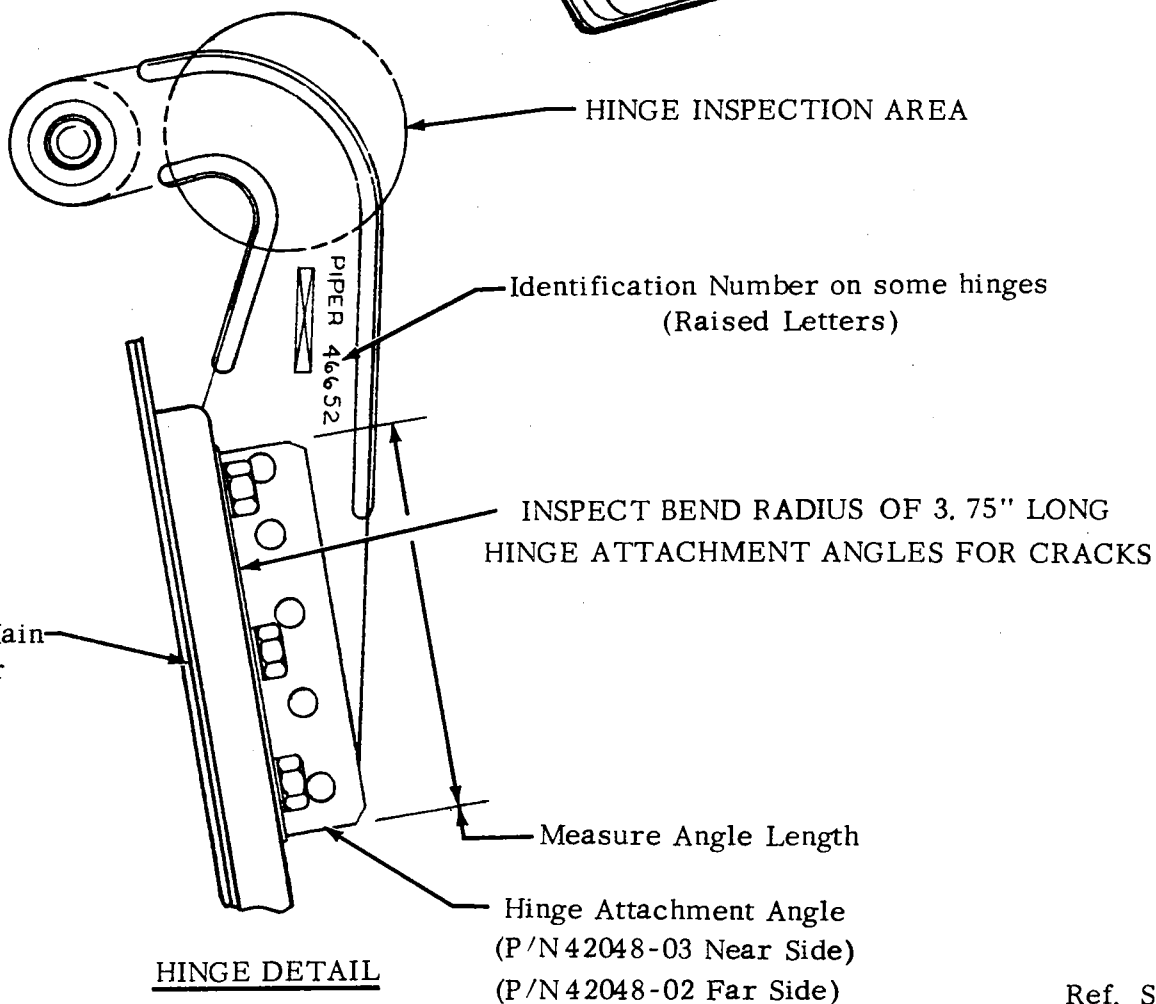
- a. One type is an aluminum forging which will have an identification number "PIPER 46652" as raised letters on the forging as shown on sketch. This type hinge requires inspection per step 3.

3. Inspect the aluminum inboard gear door hinges for cracks, in the area shown on sketch. Inspect for cracks using the Dye Penetrant Method. (All paint must be removed from the inspection area.)

4. Refer to sketch and measure the length of each hinge attachment angle (two on each hinge).
 - a. Hinge attachment angles which measure 4.00" long do not require inspection per step 5.
 - b. Hinge attachment angles which measure 3.75" long require inspection per step 5.
5. Inspect the 3.75" long hinge attachment angle(s), in the angle bend radius, for cracks. Inspect for cracks using the Dye Penetrant Method. (All paint must be removed from the inspection area.)

Gear Door Hinge
(See HINGE DETAIL)

Inboard Main Gear Door

Angle (P/N 42048-02)

Angle (P/N 42048-03)

- a. All door hinges that are cracked must be replaced with a new improved door hinge assembly (P/N 47529-32) prior to further flight. If new improved door hinge assembly (P/N 47529-32) is not available as a replacement, a new original equipment hinge assembly (P/N 46653-00) may be installed.

All hinge attachment angles that are cracked must be replaced with new angle(s) (P/N 42048-02 and/or P/N 42048-03) or by installing new improved door hinge assembly(ies) (P/N 47529-32), which include the angles, prior to further flight.
