SERVICE LETTER

No. 675

Magneto Switch Guard Installation

PA-31 and PA-31-300 Navajo
PA-31-350 Navajo Chieftain
PA-31P Navajo

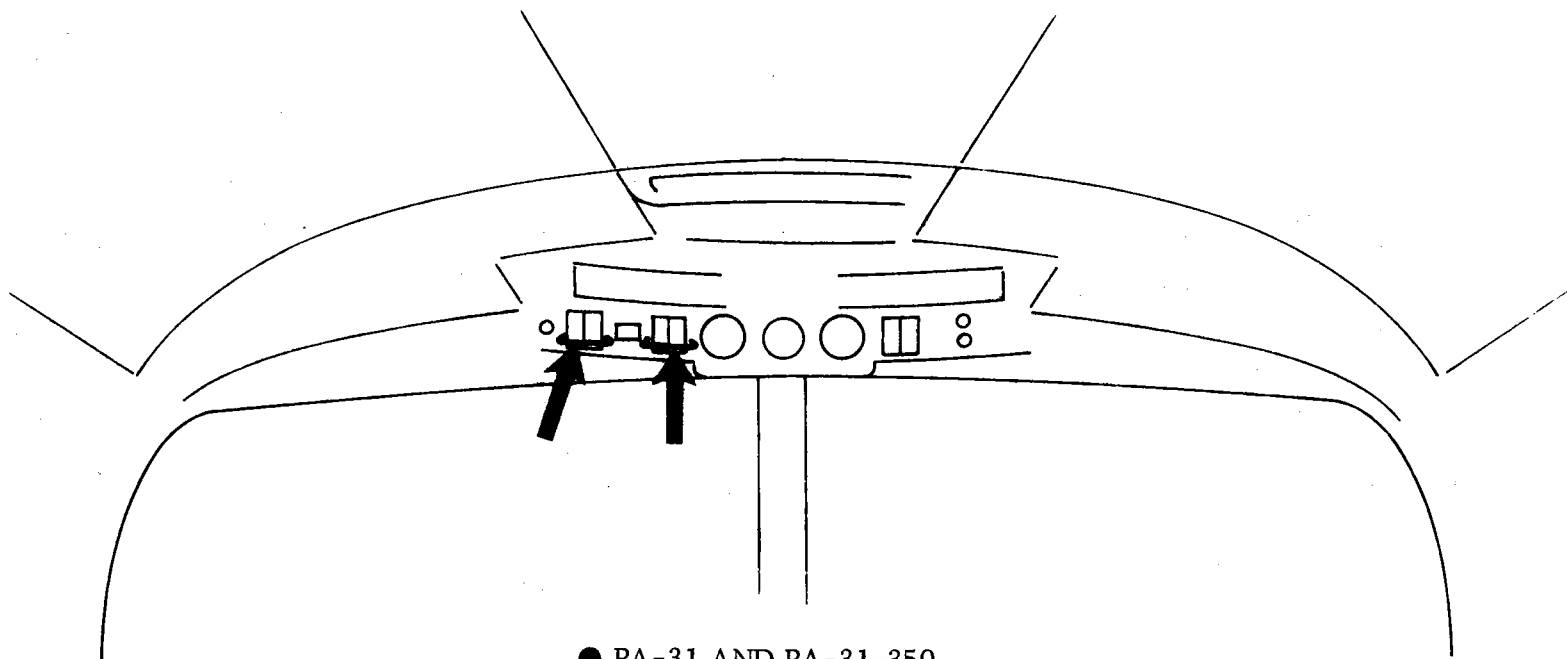
● PA-31 AND PA-31-350

The magneto switches on the Navajo Series aircraft are located on the overhead instrument panel and are "rocker" type switches. Installation of the subject switch guards will assist in preventing inadvertent magneto switch shut-off. Refer to sketch on reverse side of this letter for a general illustration of the switch guard installation.

1. PA-31 and PA-31-300 Navajos and PA-31-350 Navajo Chieftain -- reference Serial Numbers Affected, above; one (1) each per aircraft Magneto Switch Guard Installation Kit, Piper Part No. 760 789, at \$3.76A suggested retail unit price.
2. PA-31P Navajo -- reference Serial Numbers Affected, above; one (1) each per aircraft Magneto Switch Guard Installation Kit, Piper Part No. 760 790 at \$1.94A suggested retail unit price.
