SERVICE *No.* 1041 BULLETIN

**Distribution of Airborne Service Letter Number 56,
"Inspection and Cleaning of Airborne Air Filter Elements"**

Subject: Inspection and Cleaning of Airborne Air Filter Elements.

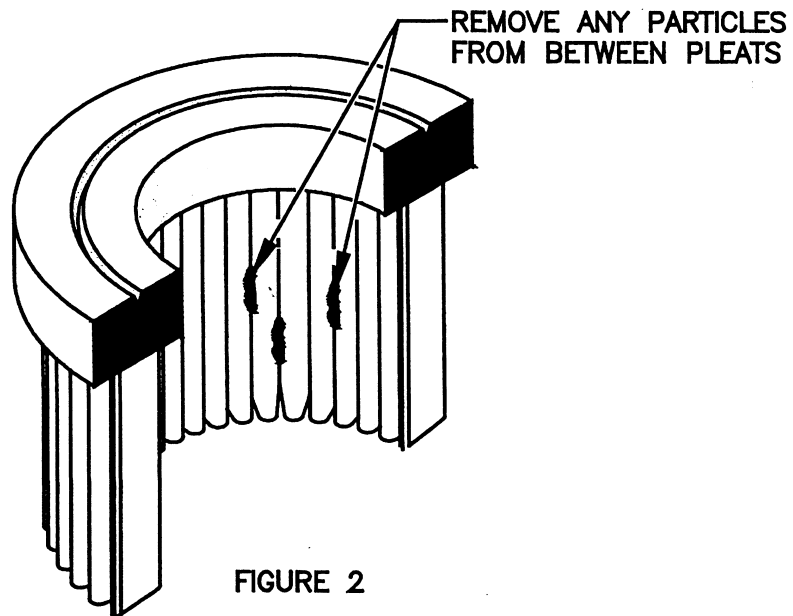
- 3) Tap the element lightly on a clean work surface in order to remove any loose particles from between the pleat tips on the inside of the paper filter (Figure 2).
